*Proceedings of Indian Geotechnical Conference 2020
December 17-19, 2020, Andhra University, Visakhapatnam*

Forensic Study of An Earth Retaining System Failure

Anil Joseph¹, S Chandrakaran² and Babu T Jose³

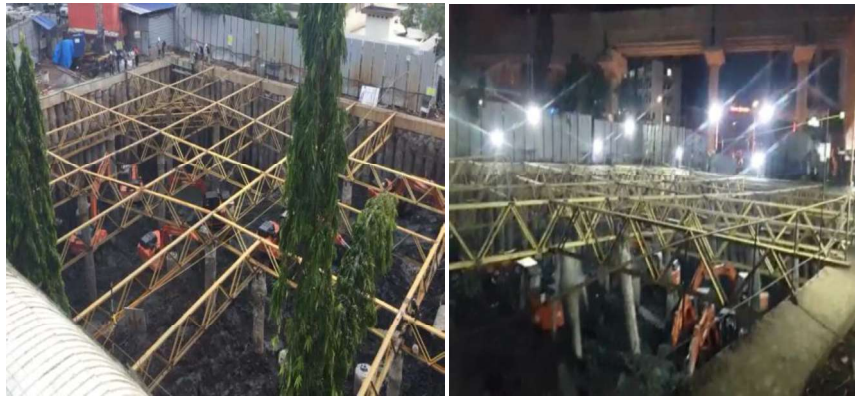
When the excavation reached a depth of 9.5m at 5.30 pm on 19/04/2018, a slight deflection of 20 mm was noticed on the shoring walls towards the north (excavated area) and the deflection increased to 100 mm by 7.00 pm. Excavation was completely stopped and workers were evacuated. Further shift increased to about 200 mm by 8.30 pm along with some creaking sound and water jets were noticed on the shoring walls and by 9.30 pm the shoring piles on the southern side came down suddenly. The photos of project area before and after collapse are shown in figure 4 (a) and 4 (b).

Fig 4. (a). Photos at different stages of touch pile system failure at Kaloor, Cochin

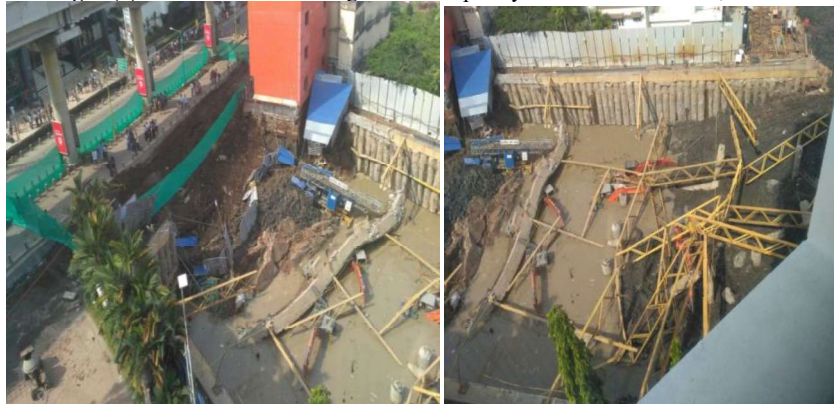
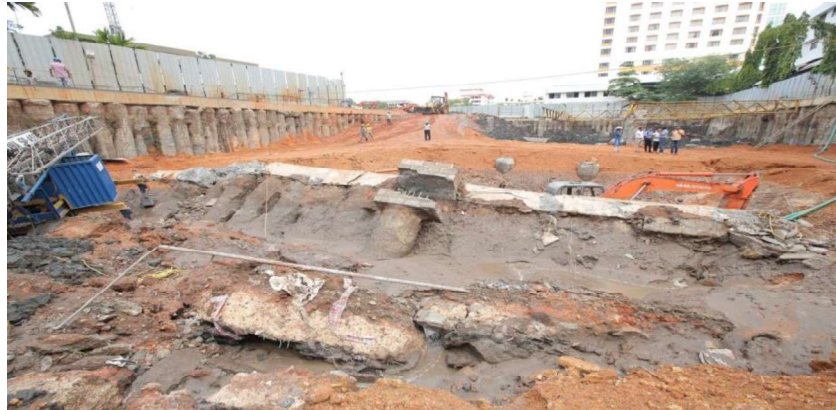
Fig. 4 (b). Photo of collapsed touch pile system at Kaloor, Cochin

- 1 The nearby road and earth had sunken by approximately 3.0m on the south side of the excavated area due to the collapse of touch pile system.
- 2 Lateral shifting of the piles was noted and the nearby earth was sunken on the south west side of the excavated area.

- 3 The building near the south west corner had a slight tilt towards the east side and cracks were noted in the building and part of the foundation was exposed. The possibility of sudden collapse of the building could have happened as this is indicative of progressive failure.

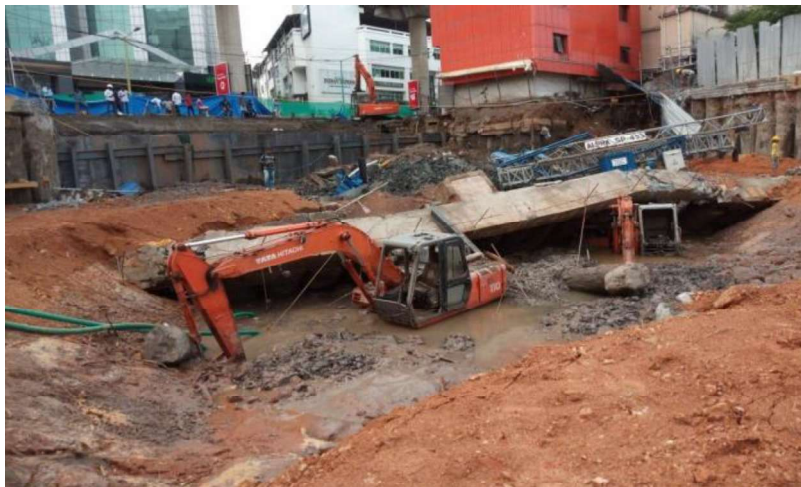
Fig 5. Refilling of soil after touch pile collapse

1. To avoid the progressive failure in the southern portion where the excavation was done up to 10m depth, red earth was refilled immediately up to 5m below the ground level.
2. Coconut timber piles extending up to 6m depth at 1m centre to centre was provided to strengthen the sunken portion of the road and red earth was filled in layer after proper compaction.
3. For ensuring the strengthening and protection of unaffected main water lines and public utilities, coconut piles were driven as an additional safety measure.
4. For the protection of the sides of the road and the soil to be filled up to formation level, double layer braced sheet piles was provided.

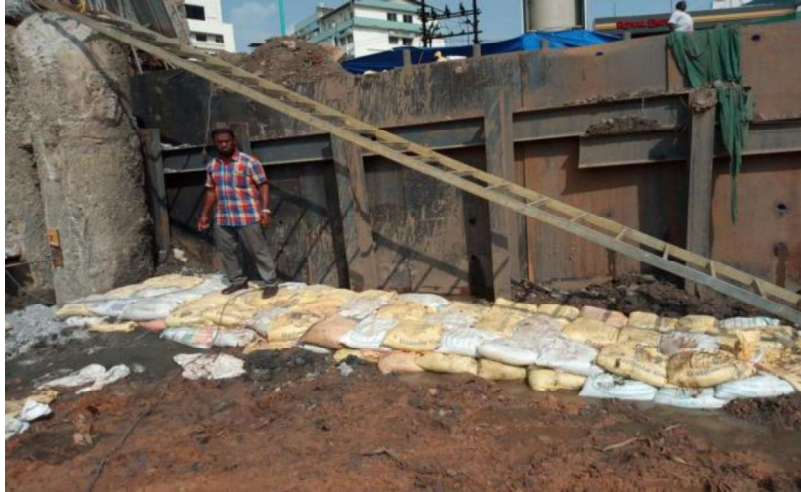
Fig. 6. Two-layer braced sheet pile system adopted near public road

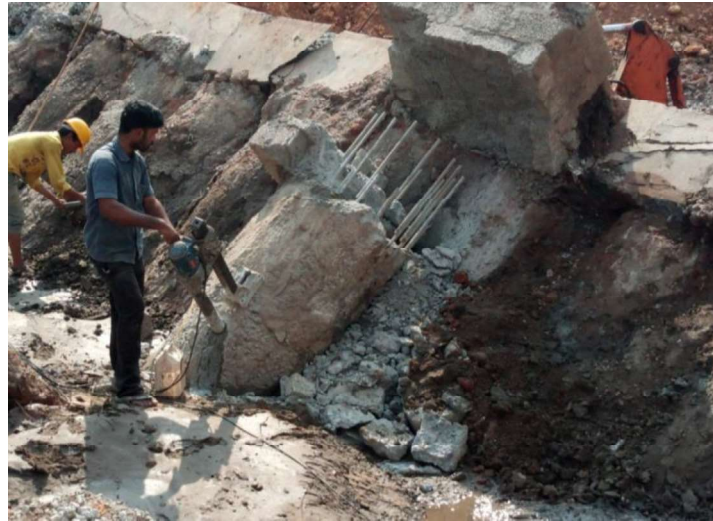
To ascertain the strength of concrete in piles and tie beams, test was conducted on touch piles and tie beams. Tests were conducted on 8 samples taken from touch pile and 3 from tie beams. It was found that cube strength values were higher than designed values. The photo of core collection and the results is shown in figure 7(a) and 7(b).

Fig. 7 (a). Extracting core from failed pile at site

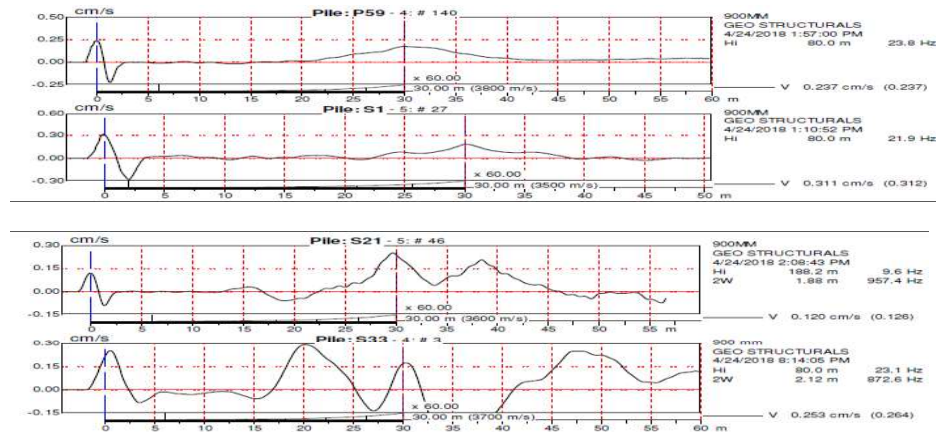
Pile integrity testing (PIT) was done on 8 R.C. bored piles which were installed in the site. The aim of testing was to assess the pile integrity for potential problems like cross-sectional changes, honeycombing, concrete quality, continuity etc. The tests were conducted in accordance with ASTM D5882 [9]. As per the test results, the collapsed piles failed at depths around 14.5m to 15.5m from the ground level. And length of the standing piles was found to be approximately 30m as specified in the drawings. The photos of integrity test in progress and the results are shown in figure 8(a), figure 8(b) and figure 8(c)

Fig. 8(b). Results of pile integrity test

Sr. No.	Pile No.	Toe Response	Length of Pile from test level (m)*	Wave Speed (m/sec)	Shaft Cross-Section and Soil Changes (From test level)	Pile Integrity	Comments
Date of Testing : 24 th April, 2018							
1.	P36	Evident	30.0m	3800	Fairly uniform pile shaft,	OK	--
2.	P39	Evident	30.0m	3800	Fairly uniform pile shaft,	OK	--
3.	P57	Evident	30.0m	3600	Fairly uniform pile shaft,	OK	--
4.	P58	Evident	30.0m	4000	Fairly uniform pile shaft. Bulge/increase in soil resistance seems evident around 12m from test level.	OK	--
5.	P59	Evident	30.0m	3800	Fairly uniform pile shaft,	OK	--
6.	S1	--	30.0m	3500	Possible defect seems evident around 6.6m from the test level.	OK	--
7.	S21	--	30.0m	3600	Possible defect seems evident around 15m from the test level.	--	Damaged pile
8.	S33	--	30.0m	3700	Possible defect seems evident around 20m from the test level.	--	--

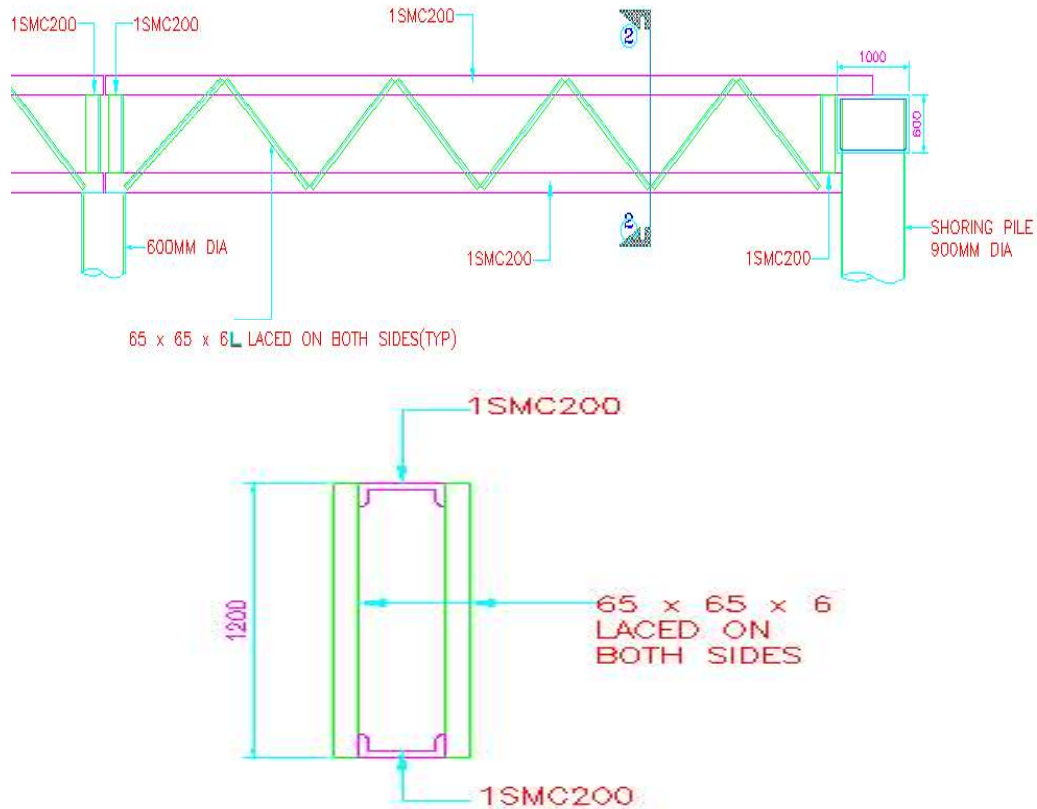
1110 kNm (179 mm deflection) and 2090 kNm (400 mm deflection) respectively. Strutting system provided comprises of two ISMC200 section connected by 65 mm x 65 mm x 6 mm L laced sections on both sides. Figure 10 shows the details of braced steel strutting system. The touch pile system comprising of 900 mm diameter piles without strutting was adequate for excavation upto 6m depth. The strutting system was found to have marginal deficiency, when the depth reached 7.5m, to take up the earth pressure and it was observed that for the depth of 10m, the provided touch piling system and strutting was grossly inadequate to take up the lateral thrust.

Fig. 10. Section of Braced steel strutting system

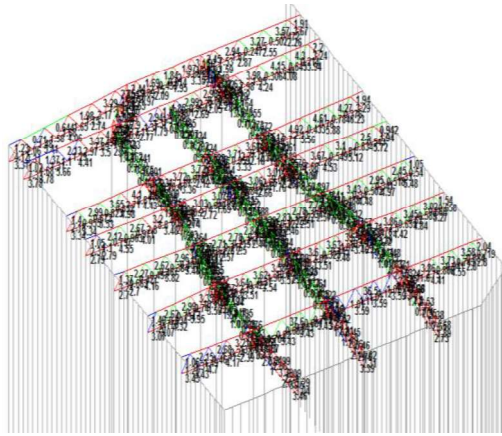
Fig. 11 (a). Utility Ratio of provided bracing system for 9.5m retention

2. The reinforcement of the shoring piles is found inadequate against bending with single strut propping system at top provided for the proposed depth of excavation of 10m.
3. The strutting system currently used is a series of trussed beams in grid pattern, but not orthogonal to each other. This will have a tendency to make the grid system skewed and to facilitate further yielding of the props.
4. The soil at current depth of excavation has turned very soft on account of water seepage. This has caused considerable weakness of the interface soil. High thrust from the shoring pile at the interface has caused yielding of this soil. Subsequent increase in unsupported length of pile is also a reason for the failure of the pile in bending.

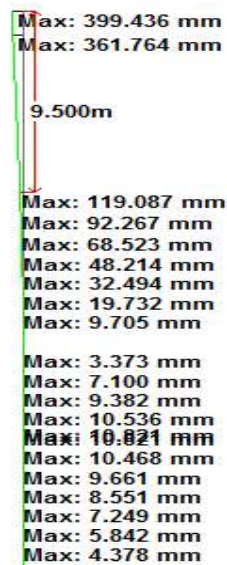
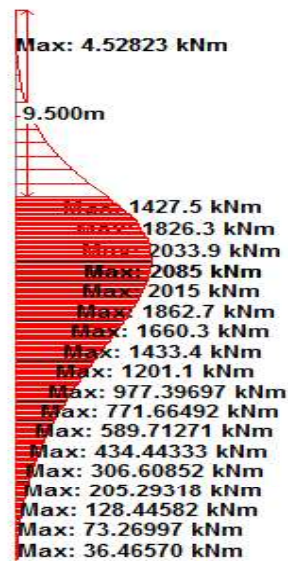
Back analysis are required to provide technical evidence to prove or disprove the hypotheses made on the cause of failures and to establish the scenarios of failure Wang et al (2013) [10], Rao and Babu (2016) [11] used back analysis to find the settlement response of different type of foundation and structures. PLAXIS and STADD software was used for the evaluation of the touch pile system and its stability as an earth retaining structure against lateral loads at different stages of excavation. Earth retention for 5m, 6m, 7.5m and 10m with 900 mm touch piles (M35, Fe 500, 30m depth) soldier piles and strutting system was checked for stability. The moment of resistance of the pile was 815 kNm. The overturning moment for excavation of 5m, 6m, 7.5m and 9.5m was 350 kNm (44 mm deflection), 633 kNm (90 mm deflection),

Fig. 12. Deflection and bending moment diagram for 9.5m retention

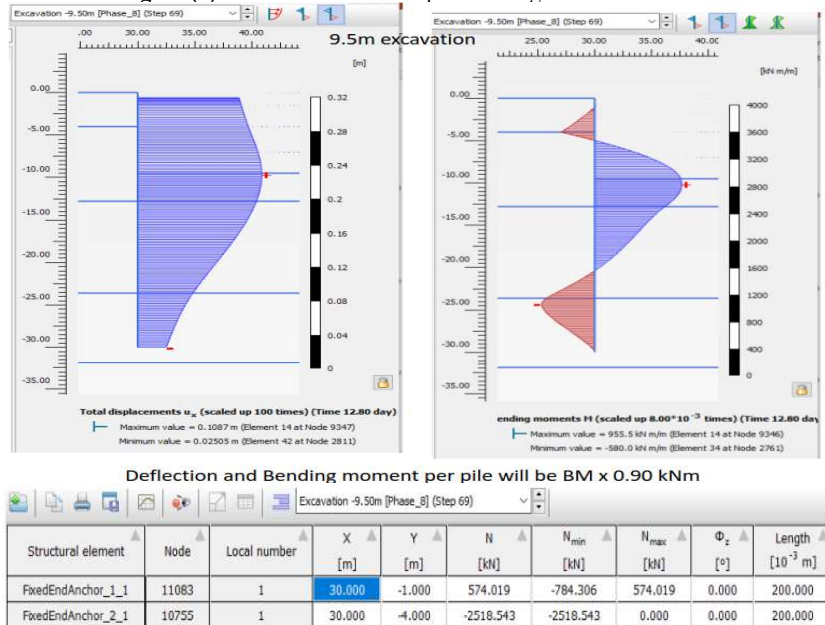
Fig. 13 (b). Deflection and Bending moment in excavation phases using PLAXIS software
