Slope Instability in the Fragile Himalaya and Strategy for Development*

R.K. Bhandari **

* Ninth IGS Annual Lecture delivered on the occasion of its 28th Annual General Session held at New Delhi, India.

** Director, Central Building Research Institute, Roorkee, India.

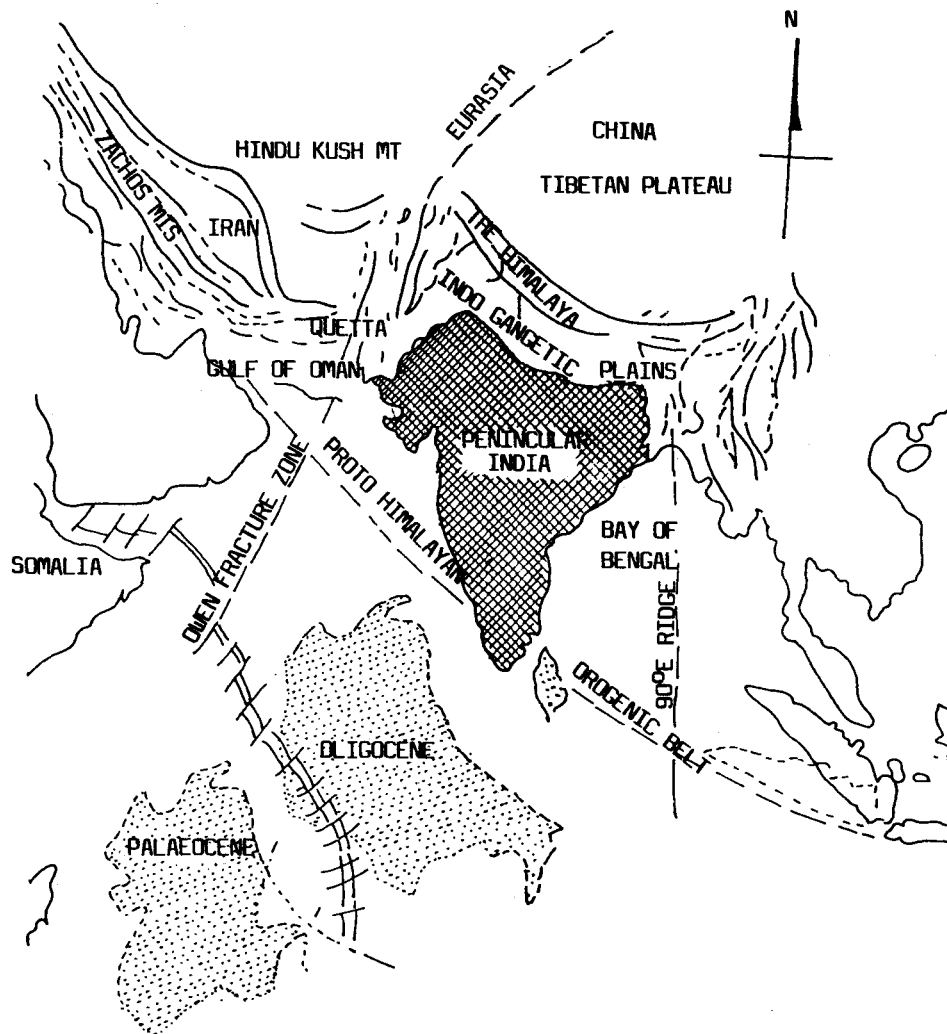
Fig 2: Tectonic Movement of Indian Subcontinent & Birth of the Himalaya (Following Farooq & Siddiqui 1981)

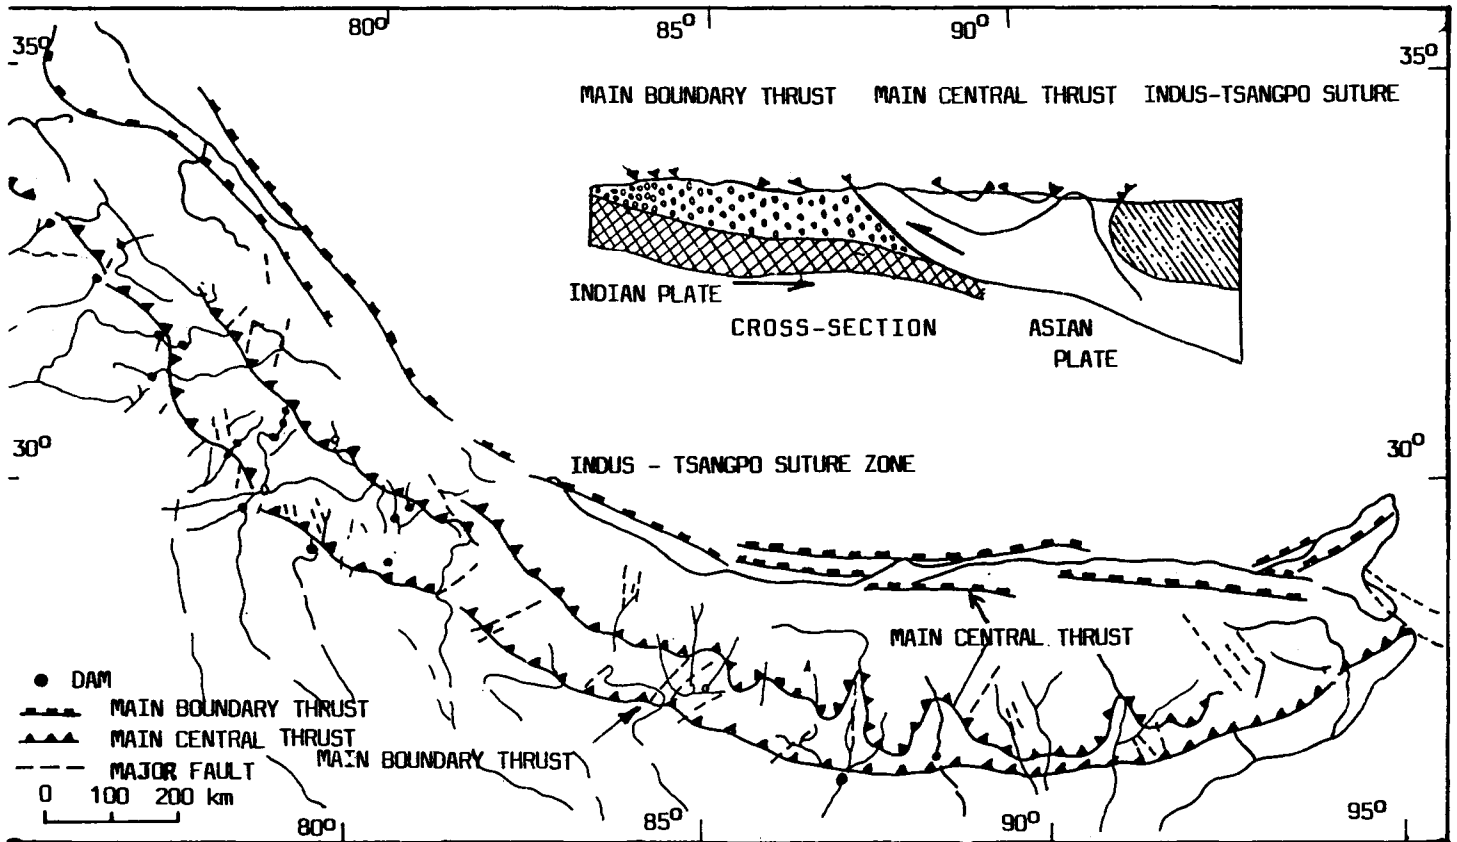
Fig 3: Tectonic Map of the Himalaya (Gansser 1974: Valdiya 1985)

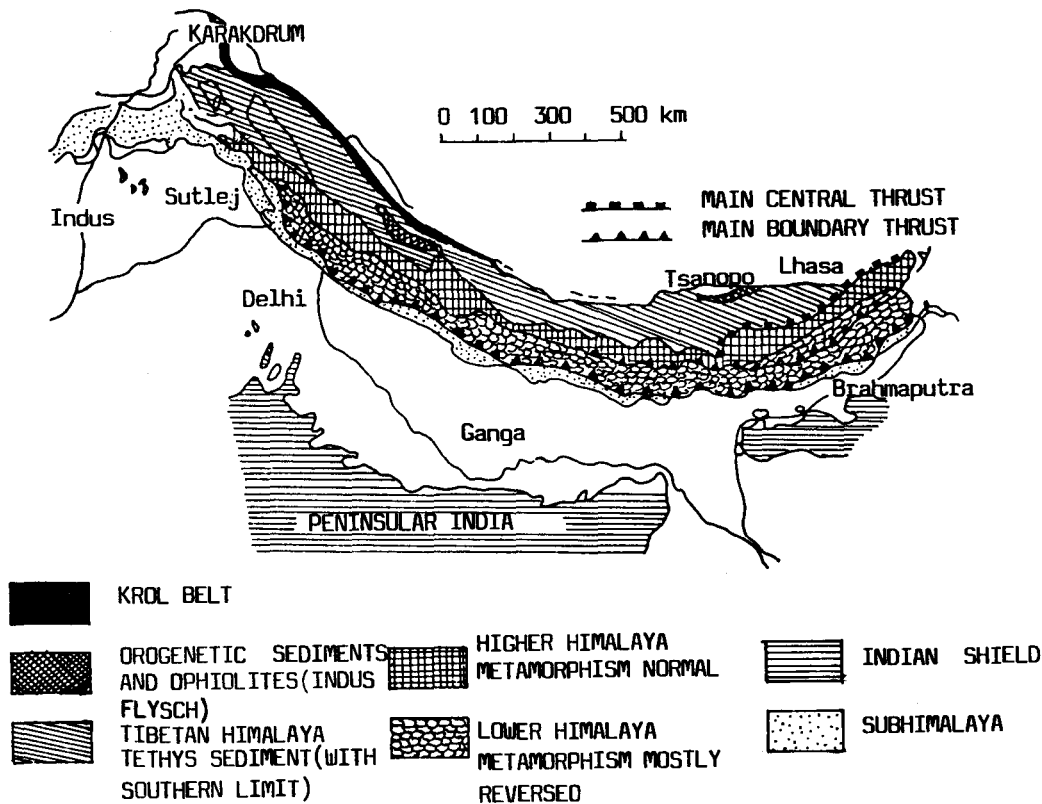
Fig 4: Geological Map of the Himalaya

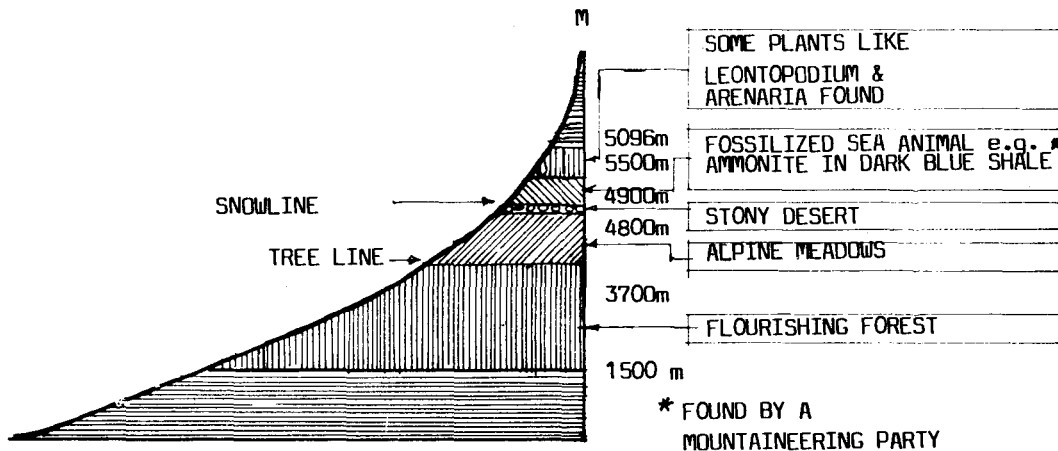
Fig 5: Climatic Variation up the Himalaya

The Himalaya displays fantastic variations of geology, geomorphology, climate and vegetation. The southern side of the Himalaya is humid with luxuriant flora whereas the northern side is arid, barren and wears the look of a desert. If one were to decide to climb up the Himalaya, India would welcome one at start with sweltering heat, then one would encounter rather damp zone with abundance of exotic vegetation, then the grassy highlands with the purest air to breathe. The real climbing would normally begin thereafter at an altitude of 4000 m or so. Thus, after passing through the tropical and the sub-tropical climates, the climbers enter an arctic like region stepping into the world of snow and ice (Fig. 5).

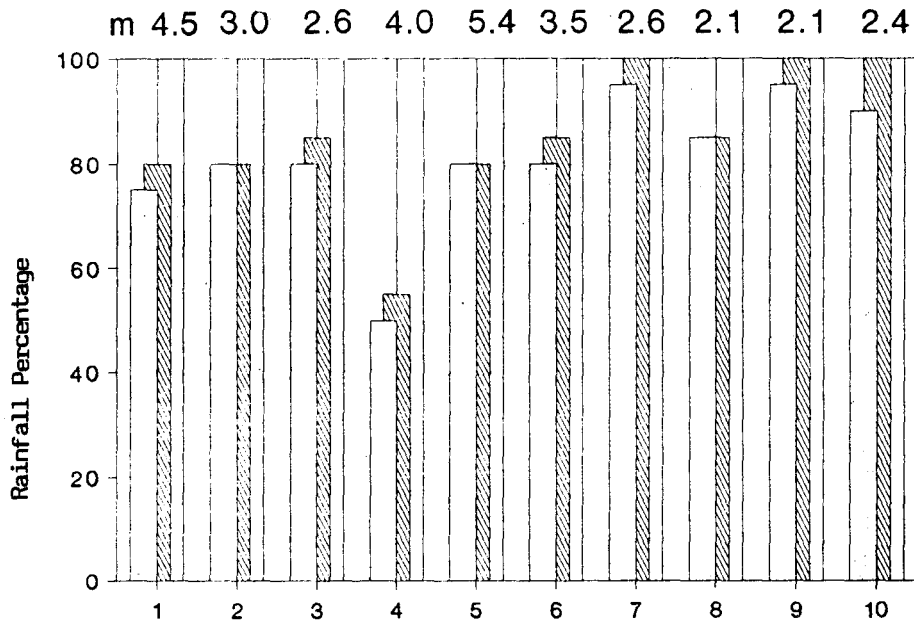
Fig 6: Typical Monsoon Rainfall vis-a-vis Mean Annual Rainfall in Sikkim

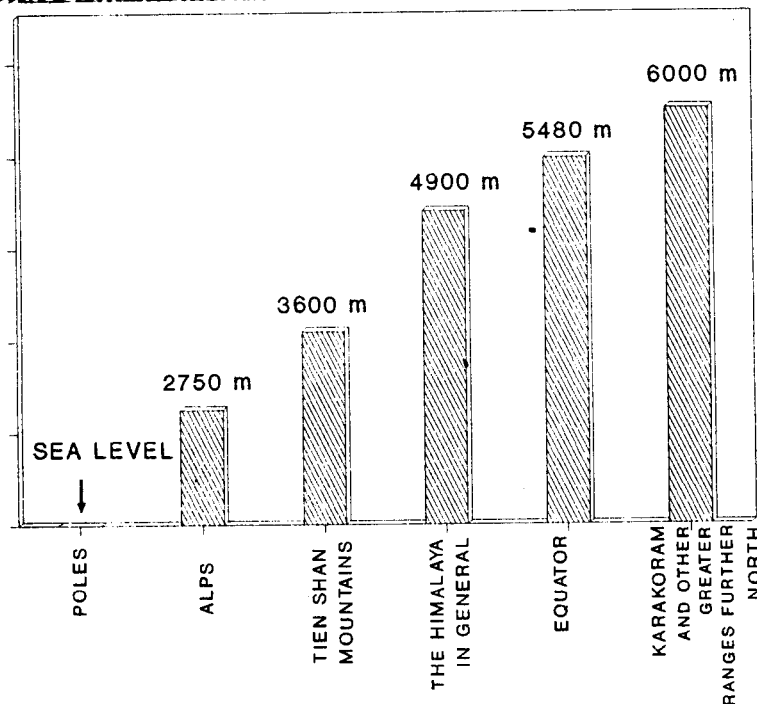
Fig 7: Himalayan Snow Line

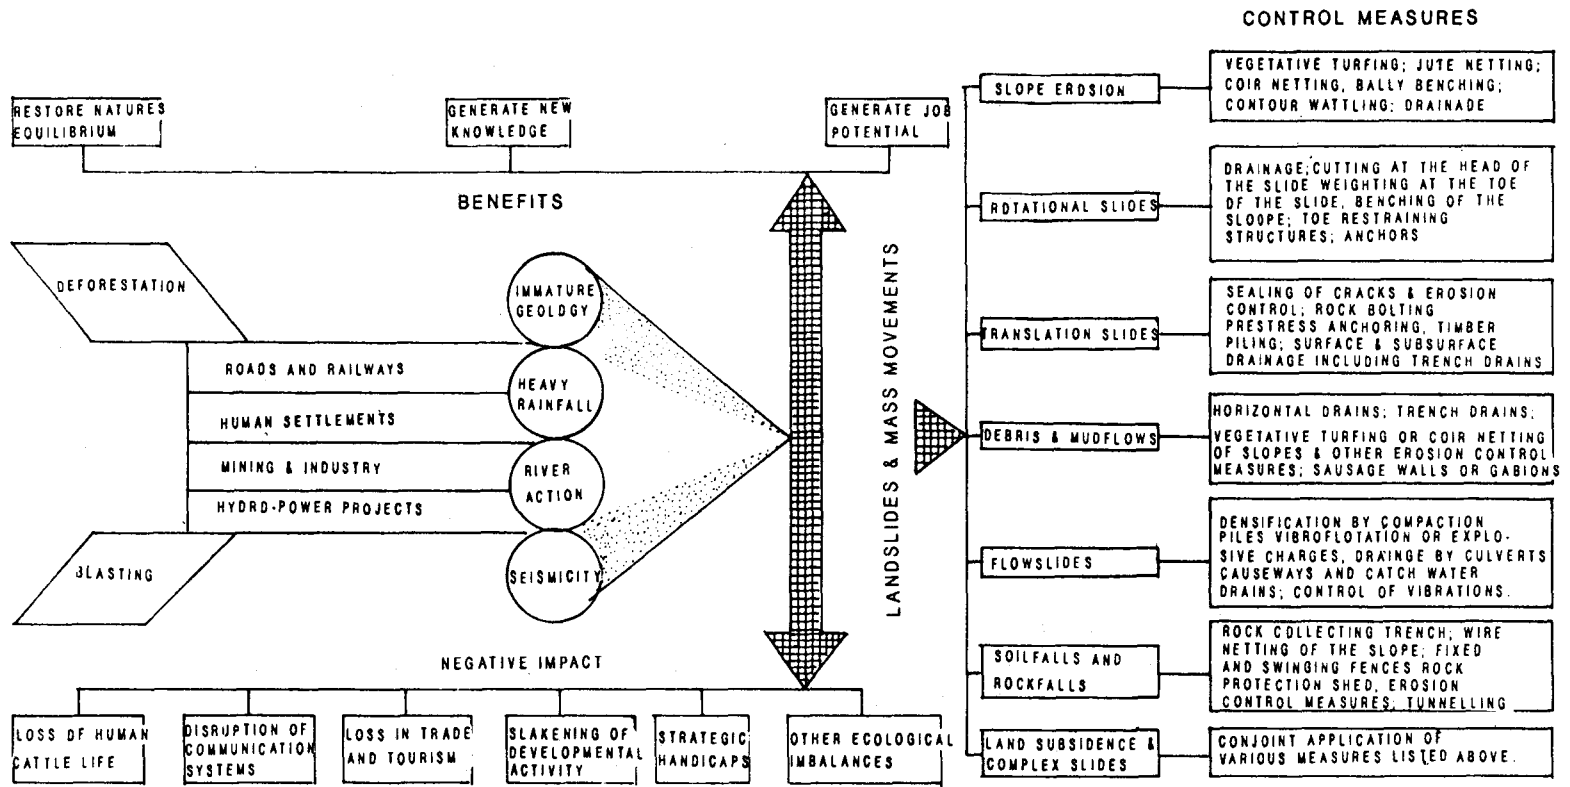
Fig 8: Factors Causing Slope Stability Problems & Common Prescription for their Control

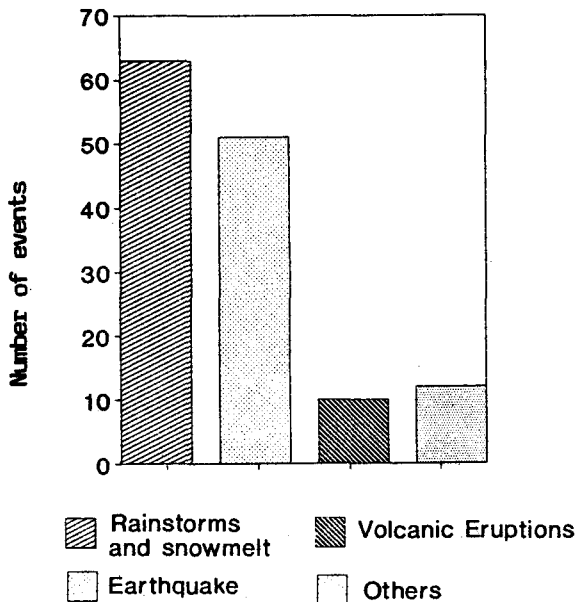
Fig 9: Causes of Landslides that have Formed Dams Based on 135 Cases from the Literature (Schuster 1986)

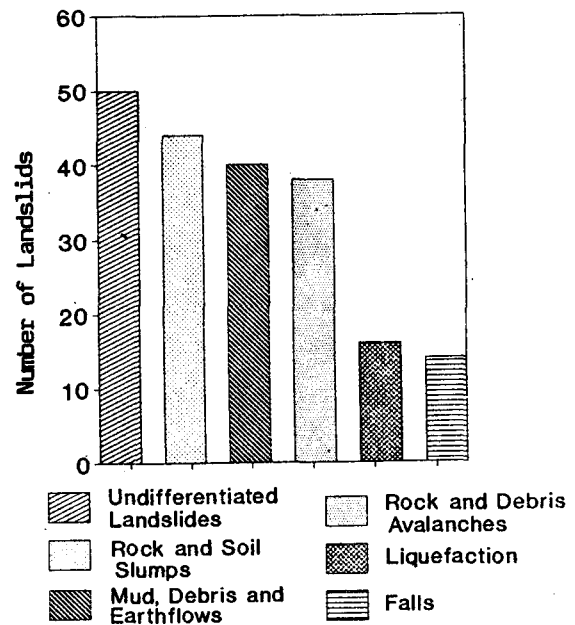
Fig 10: Distribution of Landslide Dams by Type of Landslide Based on 181 Cases from the Literature (Vernes 1978; Schuster 1986)

Landslide Dams are made by nature and are therefore quickest to appear. Nature seldom designs them for stability and therefore they usually bring about world's largest catastrophic failures rarely to be seen in the man made dams. Examples of some of the major landslide dams in the Himalaya are presented in Table 7. Similar experiences have recently been reported from the US, Canada, Pakistan, Japan and China, (Schuster, 1986). Whereas cloudbursts, flash floods, avalanches and earthquakes are the main causes of formation of landslide dams in the Himalaya, according to the analysis carried out by Schuster (1986), volcanic eruptions and other factors have also been responsible for such dams in other parts of the world (Fig. 9). Schuster also presents the distribution of landslide dams by type of landslide, based on 181 cases from the literature (Fig. 10).

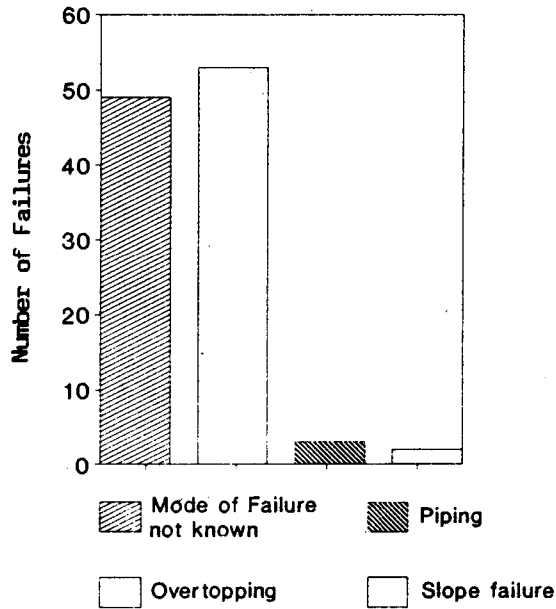
Fig 11: Modes of Failure of Landslide Dams
Based on 103 Failures from the Literature
(Schuster, 1986)

Similar to the experiences in the Himalaya, overtopping, piping and slope failure are identified as the causes of failure of landslide dams (Fig. 11). Other important factor to be considered is the life of a landslide dam which in the Himalayan situation, like that elsewhere, depends largely on dynamics of destabilising forces not fully understood at this time. Dimensions of a dam, it's mechanical characteristics, geological setting and support it

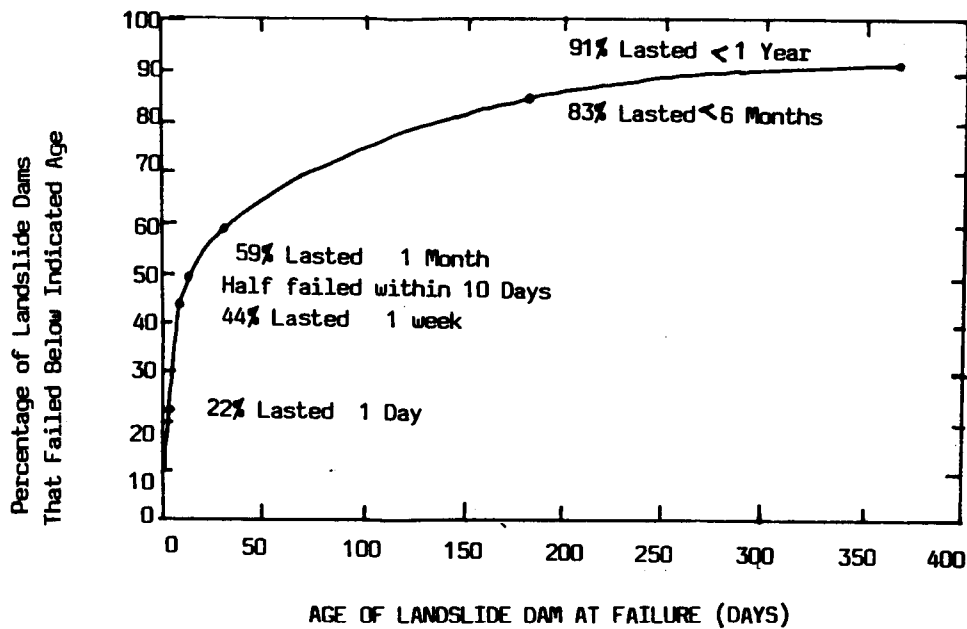
Fig 12: Length of the Landslide Dams Survived 63 Cases from the Literature (Following Schuster, 1986)

derives at interface with ambient formation contribute to stability, and magnitude and dynamics of inflow to the impoundment tends to counter that. As the height of such dams is usually seen to increase without corresponding increase of base width or flattening of slopes, failure becomes imminent close on the heels of their formation. The longest life of a landslide dam that ultimately failed in the Himalaya to the author's knowledge, is Gohana Slide Dam of October, 1983 which breached on 24 August, 1984 after nearly 10 months of its formation. Most others have hardly survived beyond 60 days of their coming into existence. The experience seems similar to the one reported in Fig. 12.

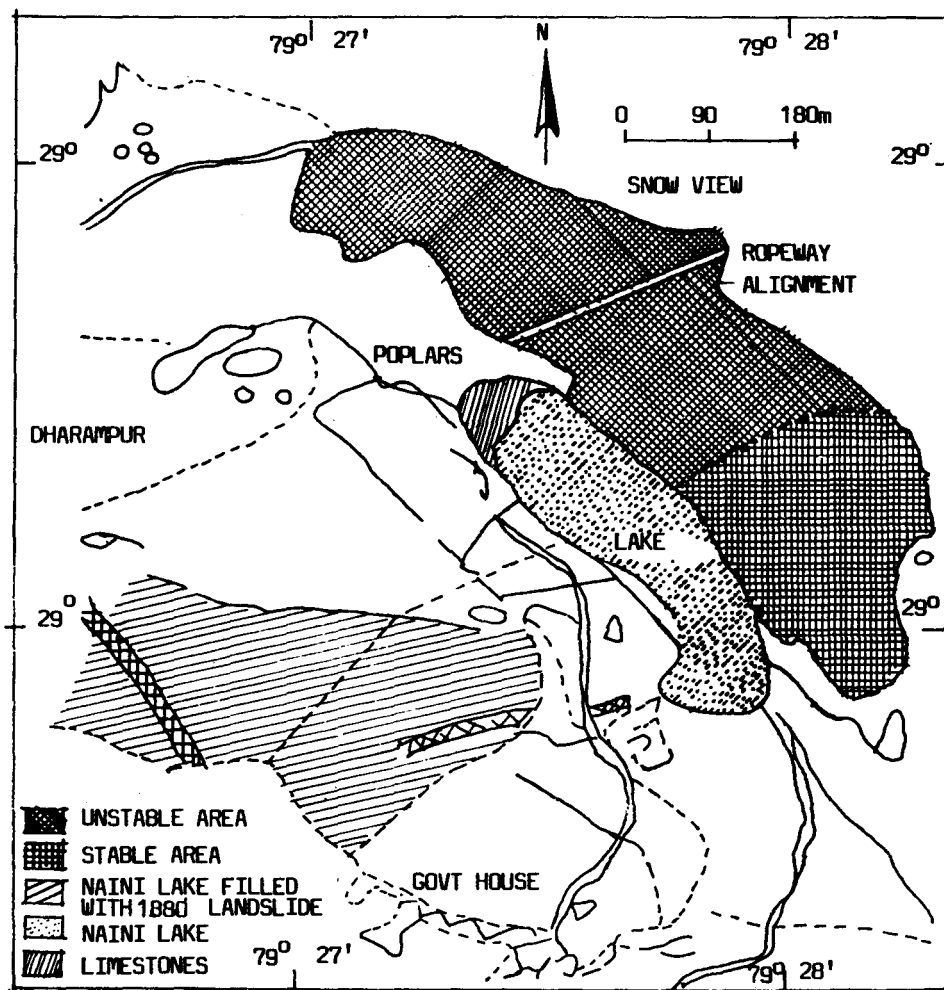
Fig 13: Plan Showing Ropeway Alignment on Sher-Ka-Danda Hill

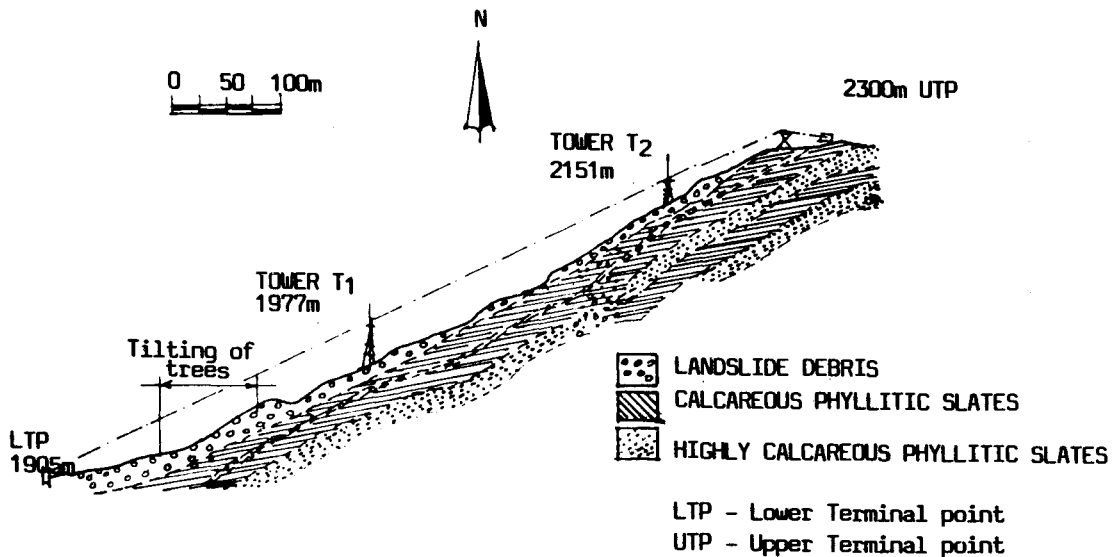
Fig 14: Subslope Profile along the Ropeway Alignment on the Sher-Ka-Danda slope, Nainital (U.P.)

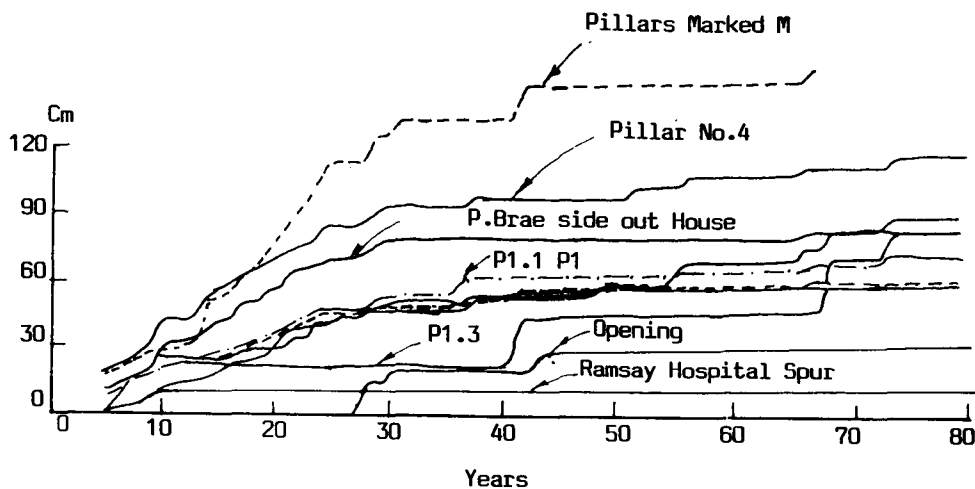
Fig 15: Vertical Movement Record of Markers on the Sher-Ka-Danda hill Nainital

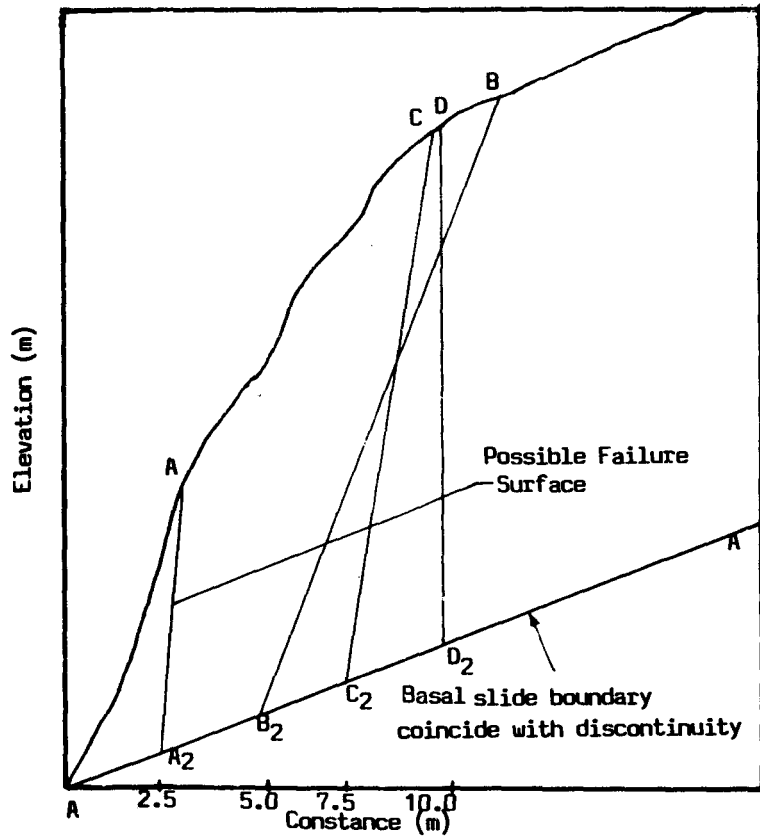
Fig 16: A typical section at T_1
 IDEALISED SLOPE PROFILE

The unit weight of rock mass was found to be 2.75 t/m³ and the slope stability was analysed for pore pressure ratio (r_p) ranging between 0 and 0.1 and seismic coefficient (μ) ranging from 0 and 0.15. Geology of the slope was suggestive of biplanar failure surface with basal slide boundary coincident with the discontinuity. Typical failure planes and influence of their orientation on factor of safety are shown in Fig. 16 and Fig. 17.

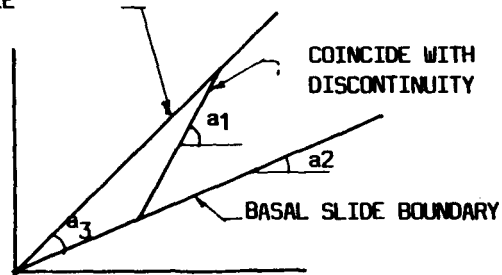
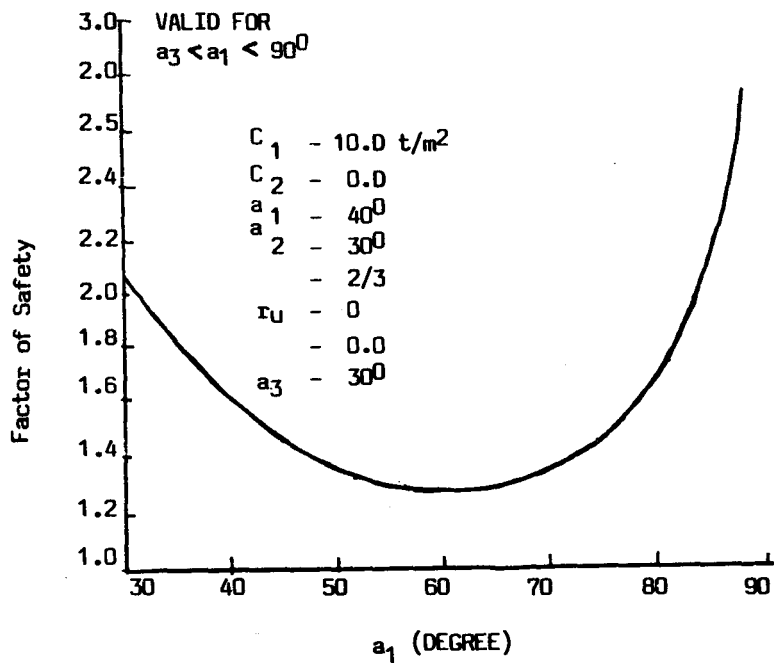
Fig 17: Influence of Orientation of Failure Plane of Factor of Safety

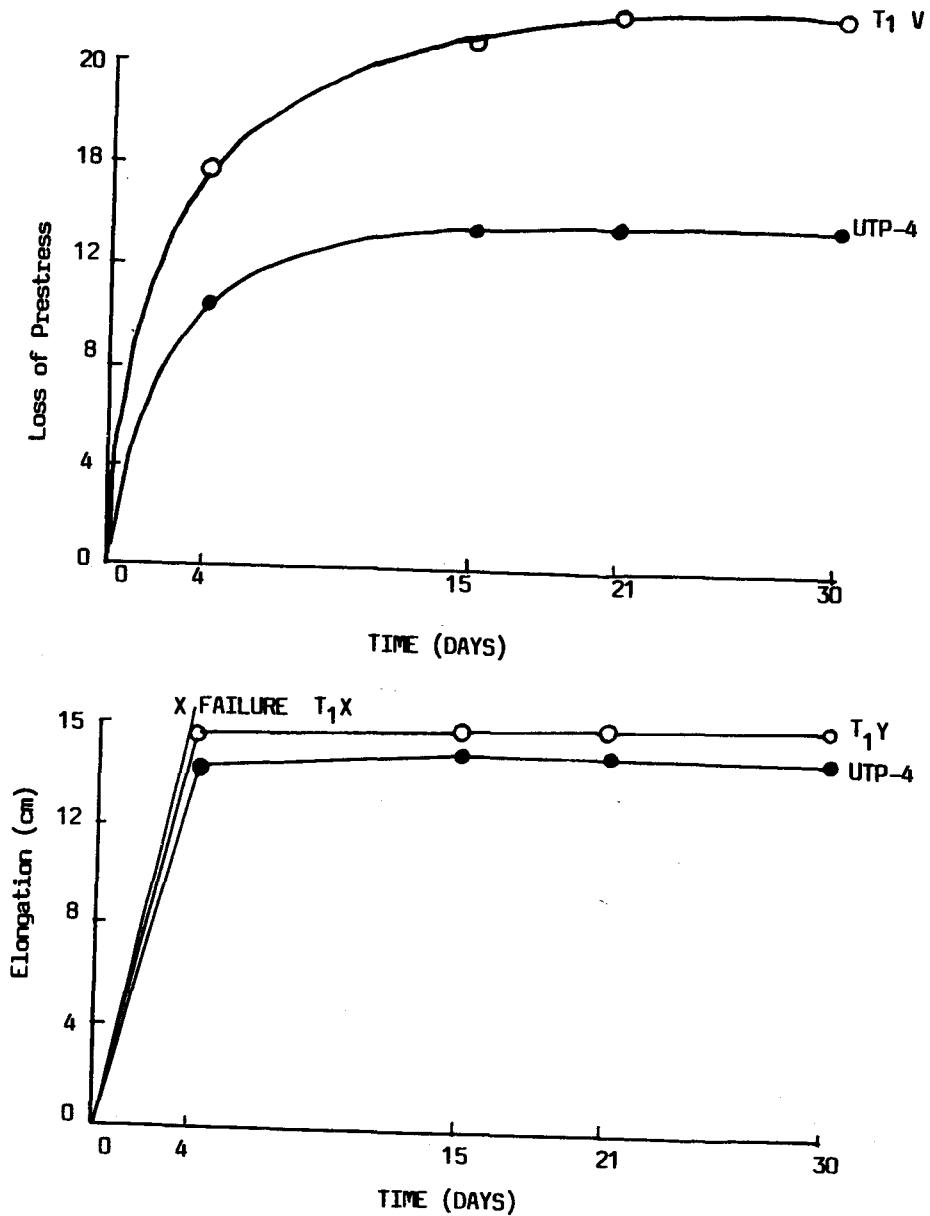
Fig 18: Time Vs % Loss of Prestress & Elongation Curves of Test Anchors

High tensile steel wires of 7 mm diameter having maximum capacity of 105 kg/mm² were used. Two extra strands were provided to guard against the failure of strands under the maximum applied load. Following Littlejohn (1976), 1.2 times of the designed load was applied at the time of testing. A typical set of timeloss of prestress and time-elongation relationships is shown in Fig. 18. Anchors were designed accordingly and stress relaxations was made up by restressing after a lapse of time.

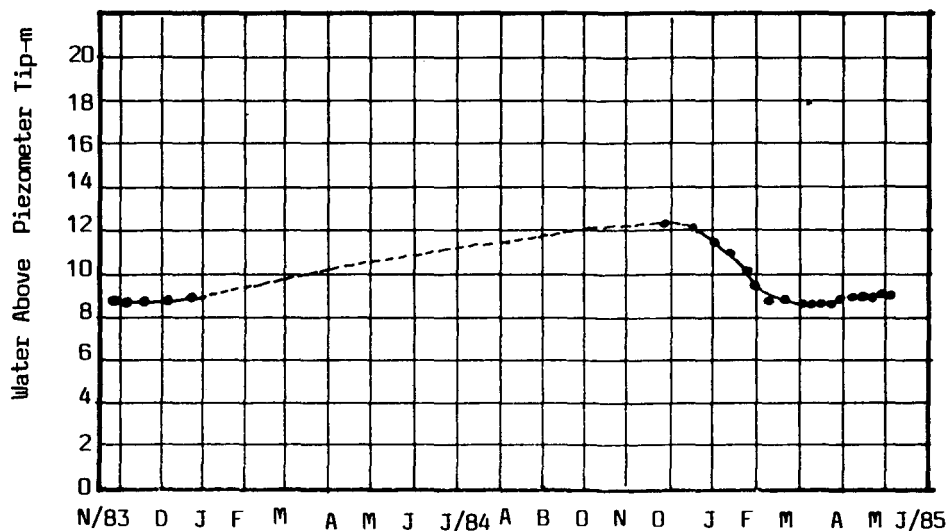
Fig 19:Water Level Above Piezometer Tip T₂P₃ at 29.5m Below Slope Surface

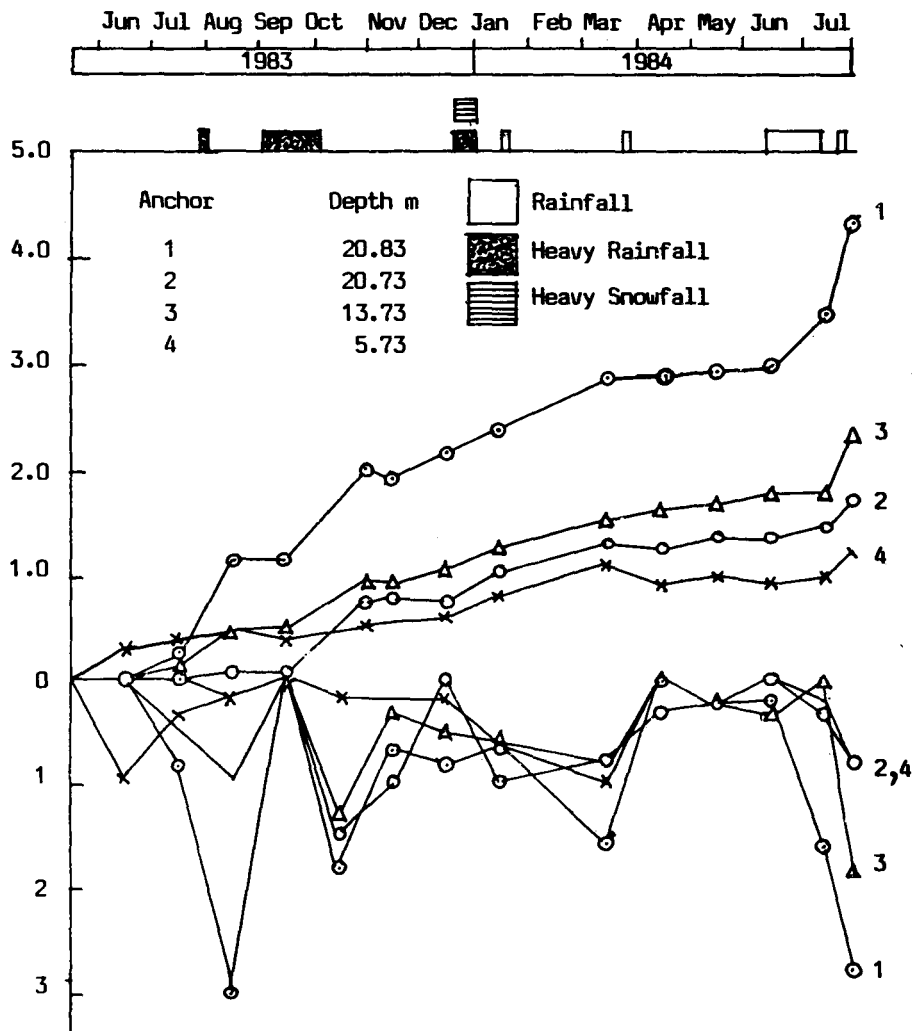
Fig 20: Variation of Total Relative Displacement & Rate of Relative Displacement with Time Near Tower T_1

Measurements on these borehole extensometers yield linear distance of the anchor points in a borehole. with respect to a mouth piece at the top end of borehole. Change in this linear distance between two observations indicates the relative displacement between the mouth piece and anchor point. A typical set of results of measurement related to borehole extensometer T₁E₂ near tower T₁ is shown in Fig. 20. Summary of observations is presented in Table 10.

The movement recorded by extensometers were largely attributed to making of deep excavations which became necessary to install tower foundations. While excuting tower foundation T₁, the excavation suffered three landslides on 25 January, 1984, 11 February, 1984 and 19 March, 1984. The rate of recorded displacements was naturally high. On the basis of the evidence for slope surface instability despite anchoring, the essentiality of vegetative turfing, drainage and restraining structures were highlighted.

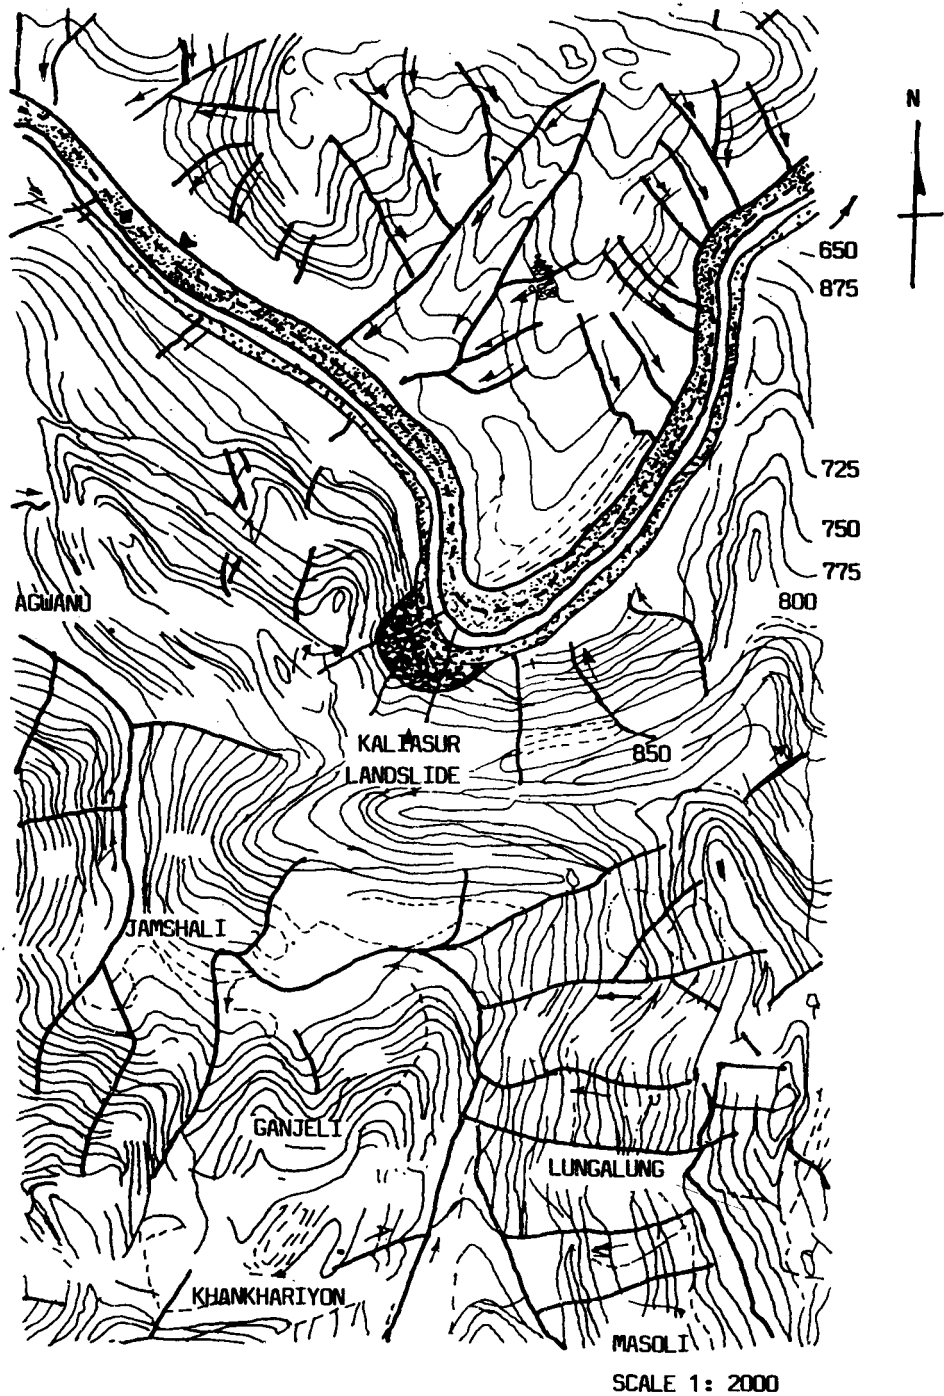
Fig.22 Contour Map Showing the Location of Kaliasaur Landslide

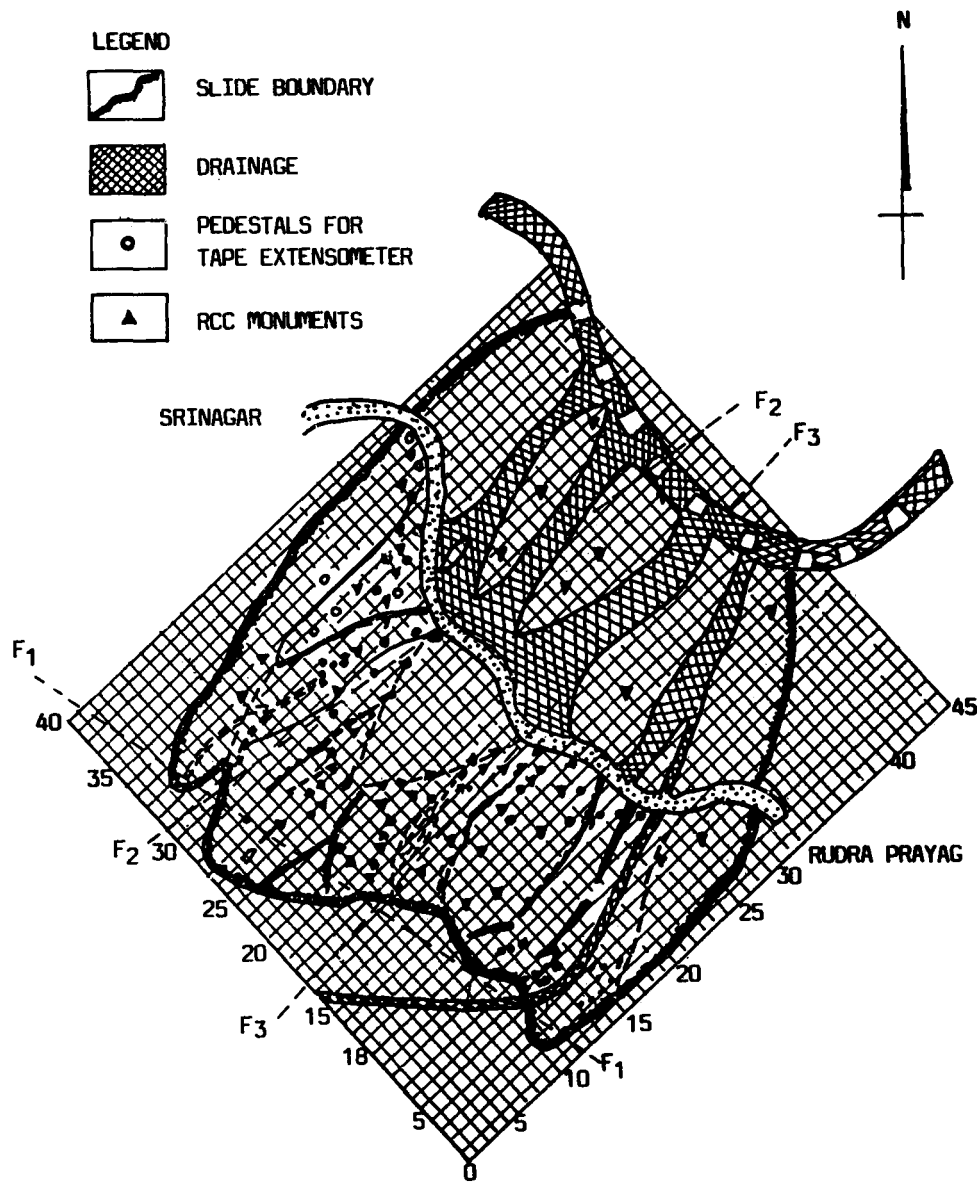
Fig 23: Scheme for Monitoring of Surface Movements of Slopes at the Kaliasaur Landslide of Hardwar-Badrinath Road

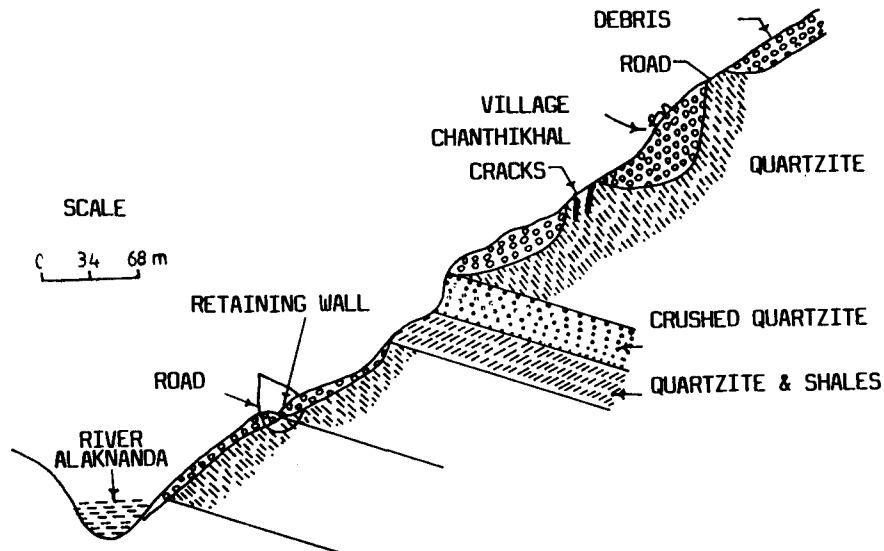
Fig 24: Cross-section of Kaliasaur Landslide at km 187 Hardwar-Badrinath Road

recurring debris slides in the colluvium cover on the slope robbing it of the vegetative cover and river action at the slope toe have also been responsible to develop the landslide to its formidable size obtaining today. A typical slide cross-section is shown in Fig. 24.

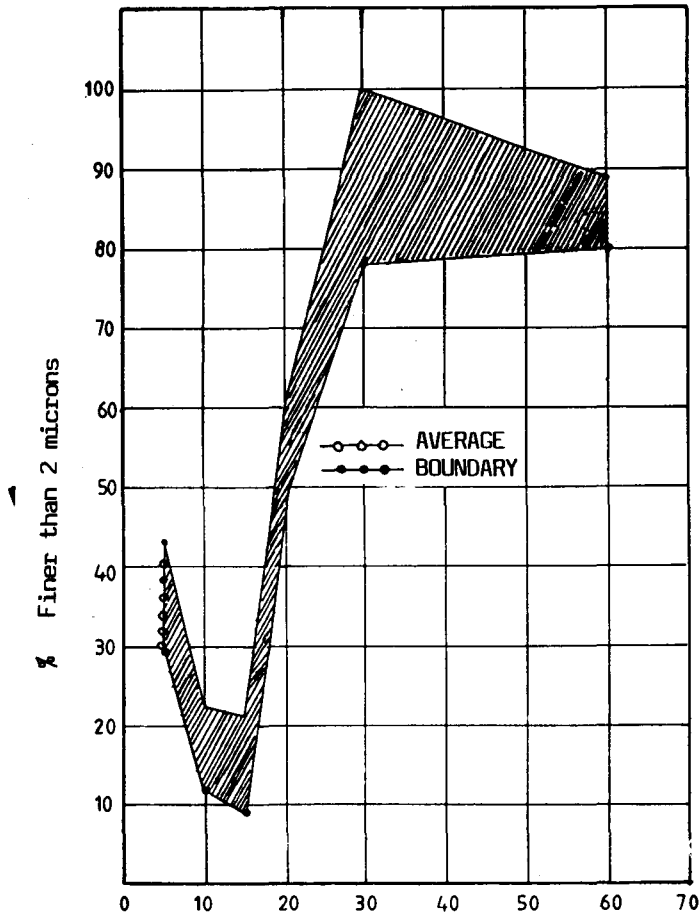
KALIASAUR SHALE SAMPLE K1

Fig 25: Particle Breakdown due to Large Developments

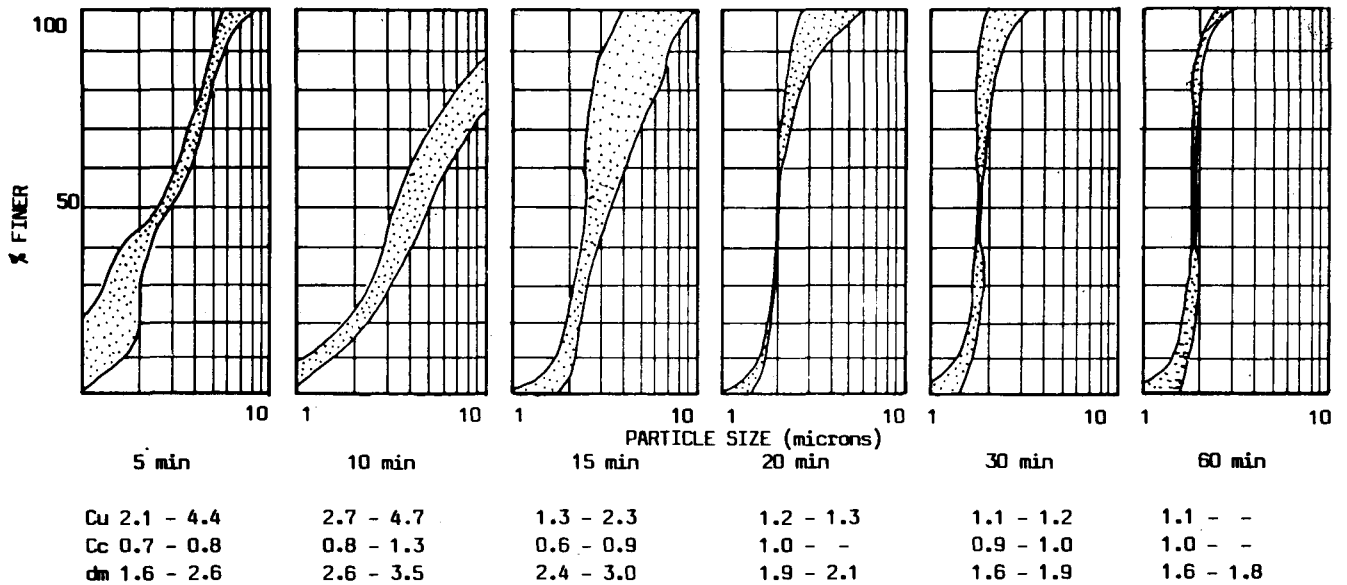
KALIASAUR SHALE SAMPLE K1

Fig 26: Grain size Variation on Particle Breakdown due to Large Displacements

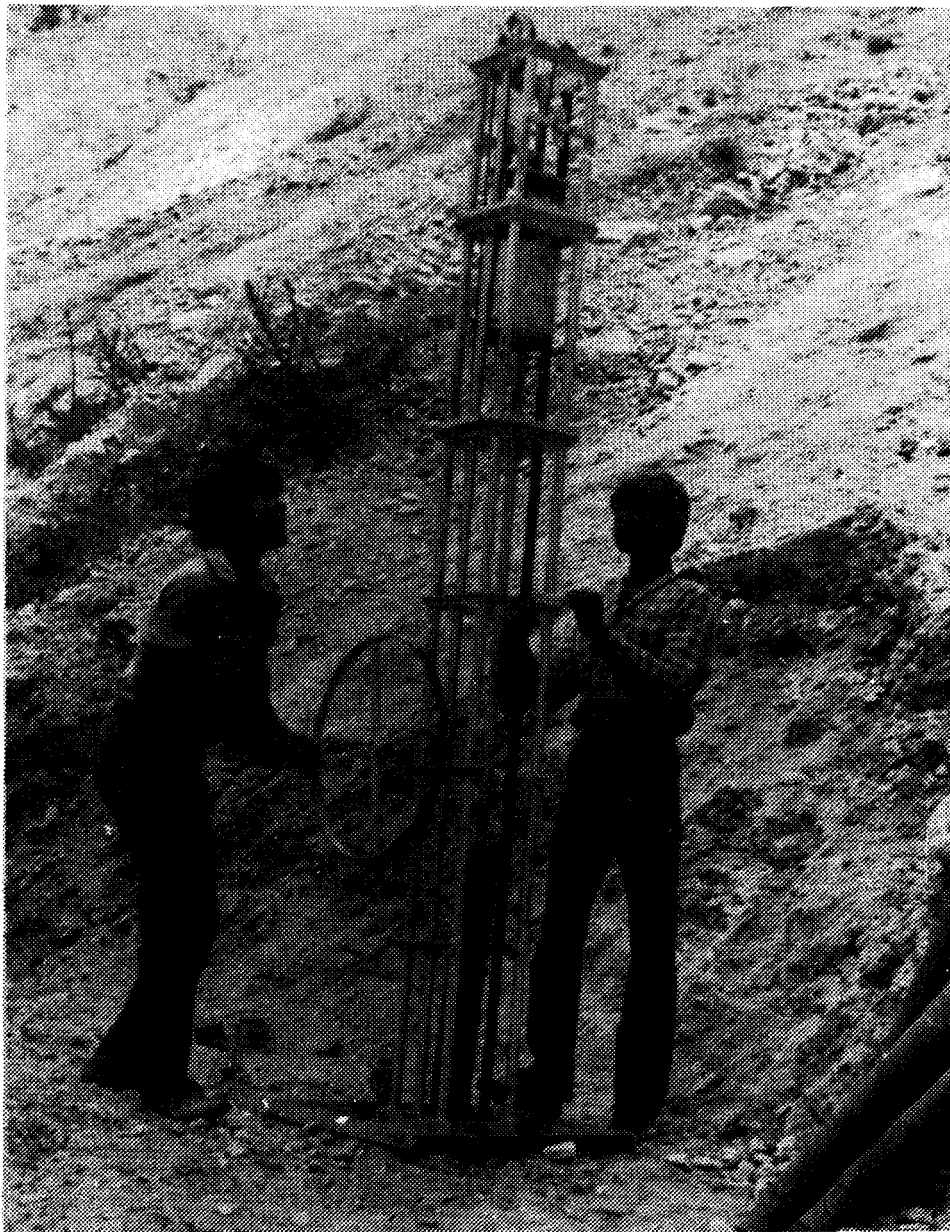
Figure 27 Stitching of colluvium on the slope at Kaliasaur by a simple Lowcost Timber piling Machine

provide 'stitch action' that helps to hold the earth mass. Such piles are usually stiffened laterally by horizontal runners of timber. For example some 60,000 ballies of 12.5-15 cm diameter, 3 m long were driven to depths ranging from 1.5 to 2.0 m to stabilise Padamchen Slide in Sikkim. After stiffening the ballies laterally, the space (in between) was filled up and the vertical parts were tied with each other by 8 SWG binding wire. The bally cribbing and terracing were also used to stabilise a shallow landslip at the rear slopes of Idgah substation building in Shimla, Bhandari (1973). After intensive field trials, 20 cm diameter, 3 m long ballies were driven to a depth of about 2 m using a 30 kg hammer, about a metre apart. These ballies were braced on the uphill side by means of 15 cm diameter, 3 m long ballies in three tiers using dogs, nails and 8 SWG wire.

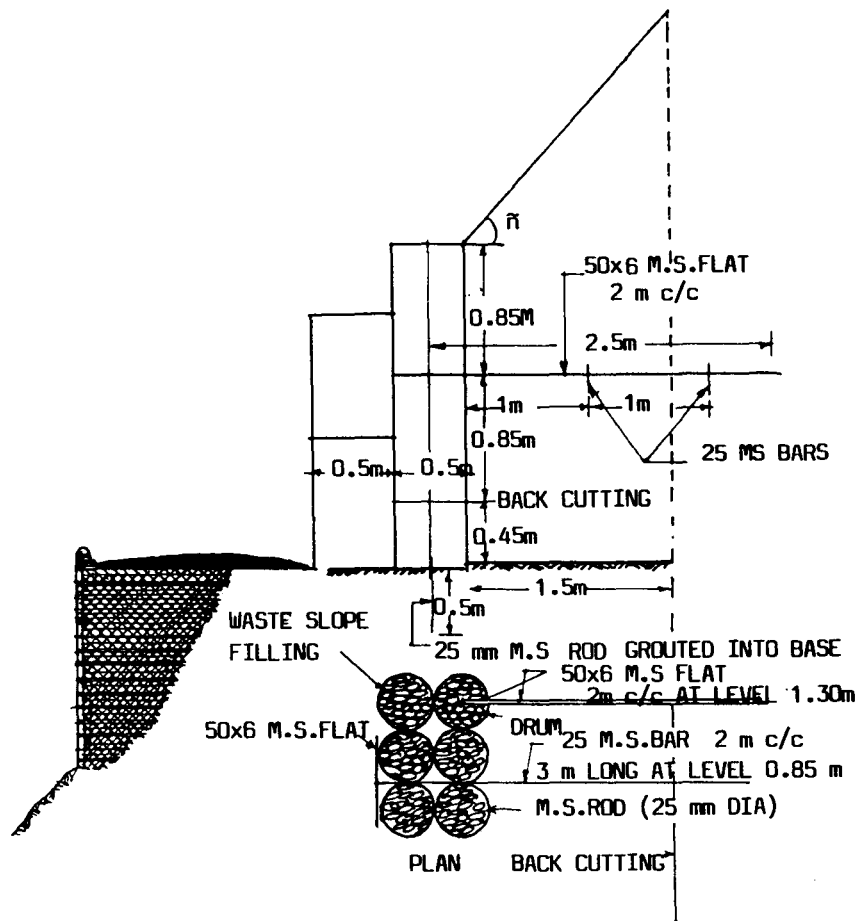
Fig 28: Anchored Drum Diaphragm Wall Built of Slope Waste and Empty Bitumen Drums

retaining walls to stabilise slopes. It has been conclusively demonstrated that empty bitumen drums available in abundance through construction agencies like DGBR can be interconnected vertically and laterally, filled up with debris to achieve gravitational effect and suitably anchored to obtain desired level of stability. They could be reasonably designed as anchored diaphragm walls. Cross-section and other details of a nearly 100 m long such wall built by the CBRI at Kaliasaur to stabilise slope immediately uphill on the road is shown in Fig. 28. Its sequence of construction is shown in Fig. 29. A view of the wall after construction, taken in August, 1986 at a time when debris flow in the slope cover was at its peak, is shown in Fig. 30 and a close up is shown in Fig. 31.
