Slope Instability in the Fragile Himalaya and Strategy for Development*

R.K. Bhandari **

* Ninth IGS Annual Lecture delivered on the occasion of its 28th Annual General Session held at New Delhi, India.

** Director, Central Building Research Institute, Roorkee, India.

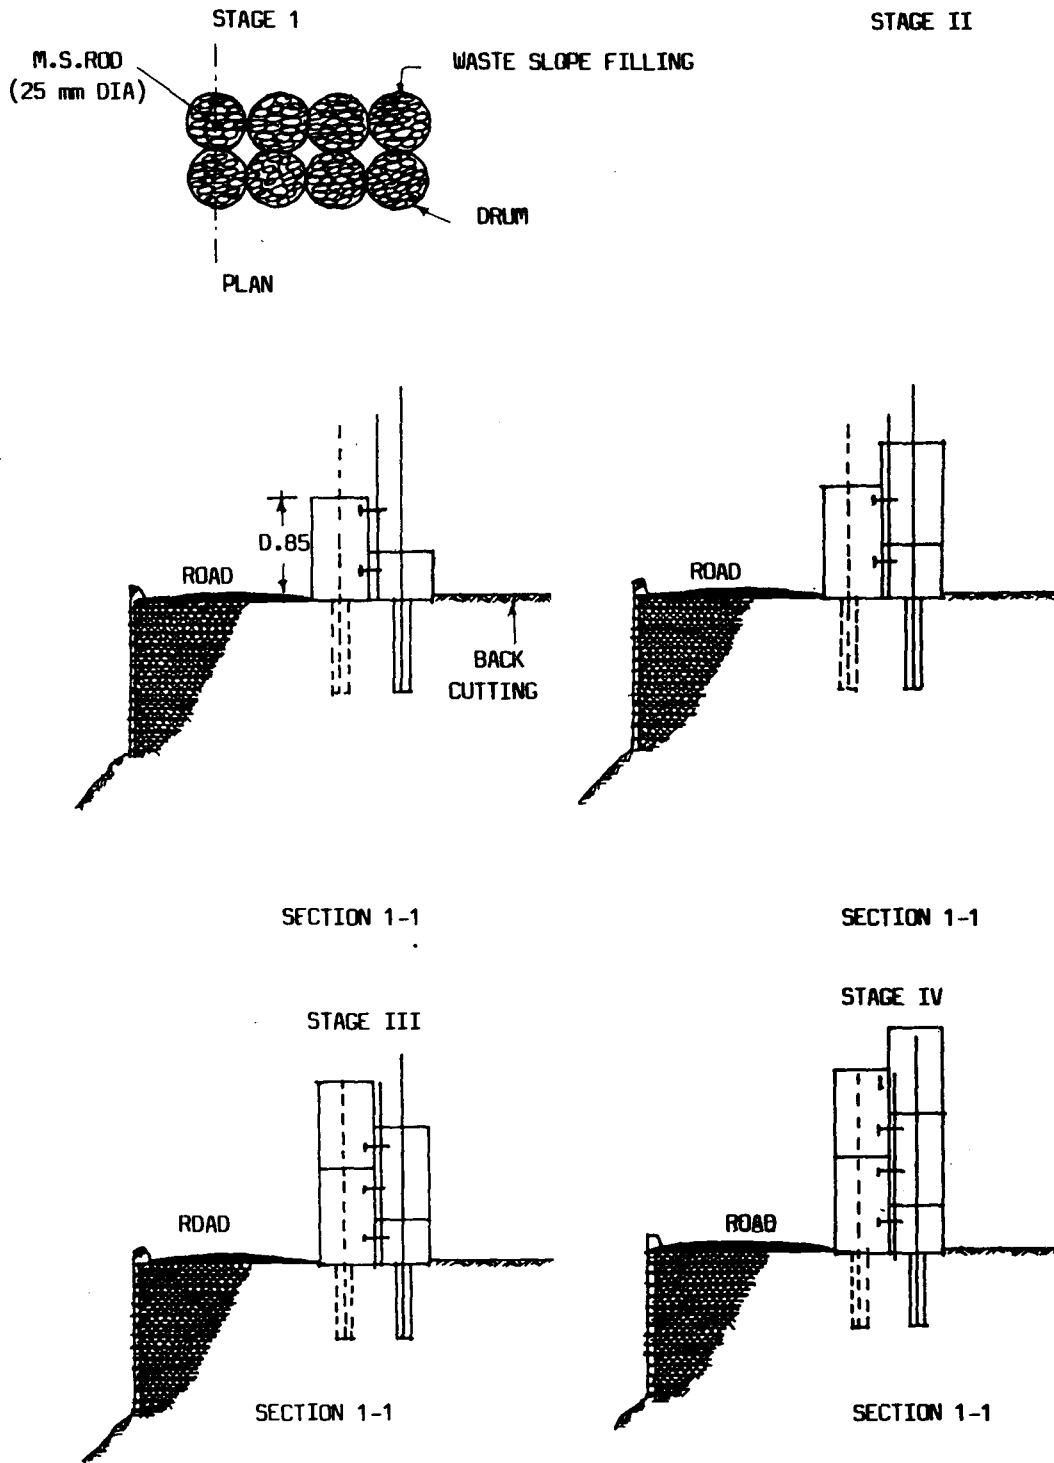
Fig 29: Sequence of Construction of Anchored Drum Diaphragm Wall

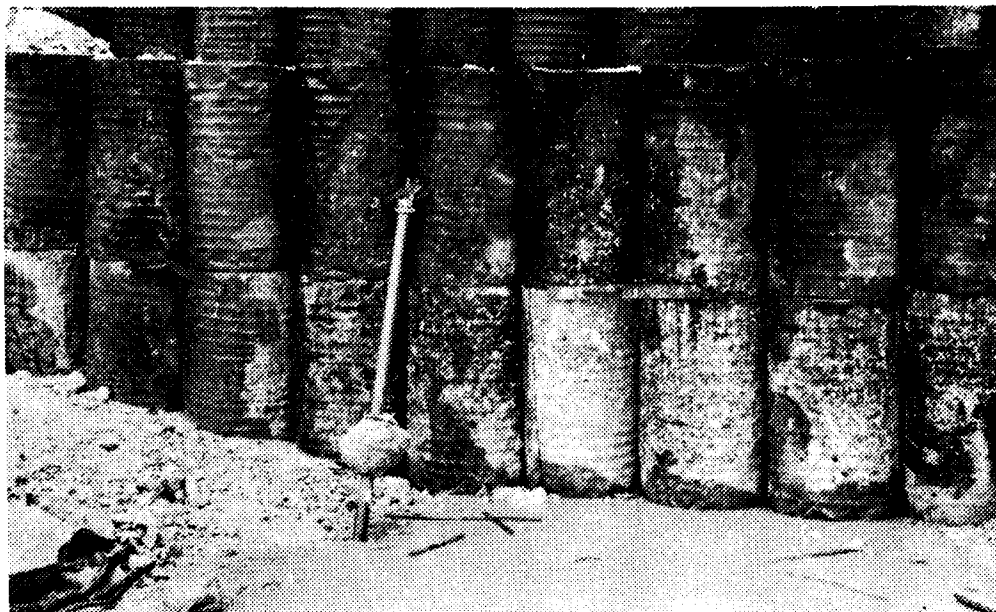
FIGURE 31 A Close up of the Drum-Debris Diaphragm Wall

retaining walls to stabilise slopes. It has been conclusively demonstrated that empty bitumen drums available in abundance through construction agencies like DGBR can be interconnected vertically and laterally, filled up with debris to achieve gravitational effect and suitably anchored to obtain desired level of stability. They could be reasonably designed as anchored diaphragm walls. Cross-section and other details of a nearly 100 m long such wall built by the CBRI at Kaliasaur to stabilise slope immediately uphill on the road is shown in Fig. 28. Its sequence of construction is shown in Fig. 29. A view of the wall after construction, taken in August, 1986 at a time when debris flow in the slope cover was at its peak, is shown in Fig. 30 and a close up is shown in Fig. 31.

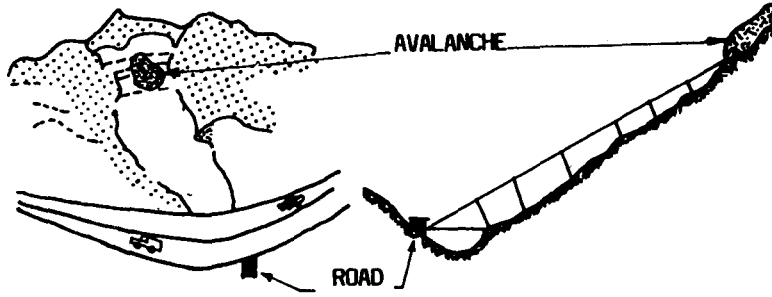
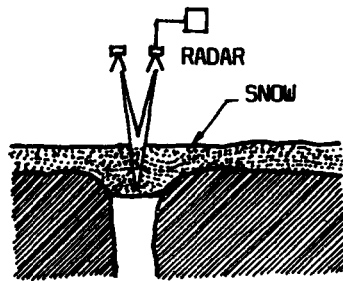
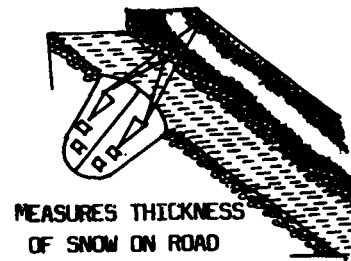
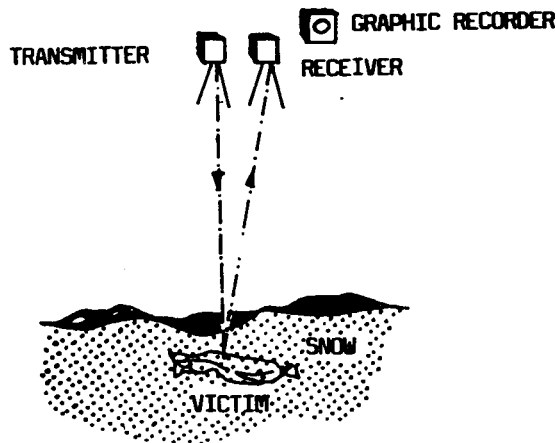
CONTROLS TRAFFIC AND MONITOR AVALANCHE MOVEMENT

DETECTS CREVASSE ROCK

SEARCH OF AVALANCHE VICTIMS

Fig 32: Major Application of Radar

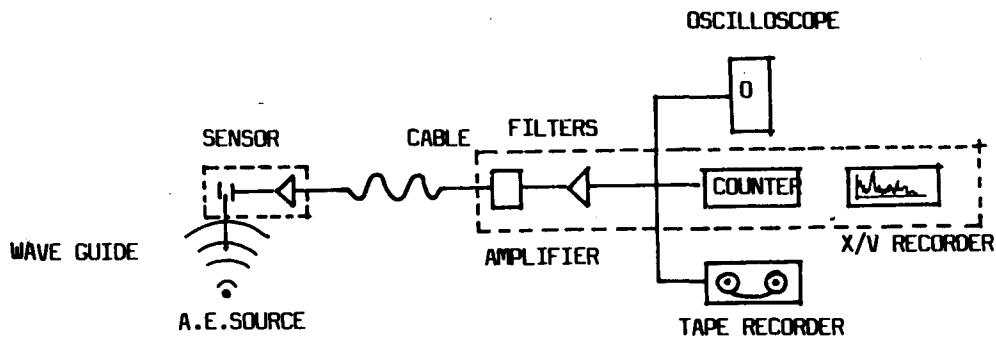
Fig 33: Acoustic Emission Monitoring System

which propagate radially from the source location. These stress waves of sub audible level, usually called acoustic emissions, can be sensed by a suitable transducer, Fig. 33. The signal can be easily amplified when received by acoustic emission system so as to quantify the measurement. Quantification parameters imply acoustic emission count, acoustic emission count rate, amplitude and frequency distribution.

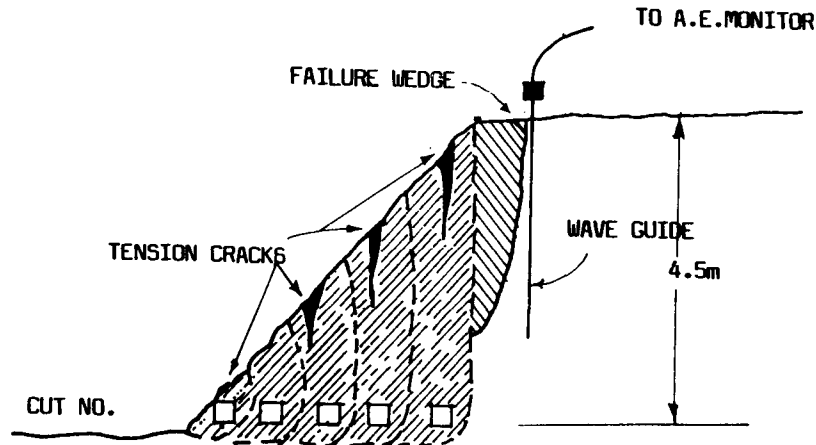
Fig 34: Failure of a Cutting by Successive Excavation at its Toe (Kaener, McCabe & Lord, 1980)

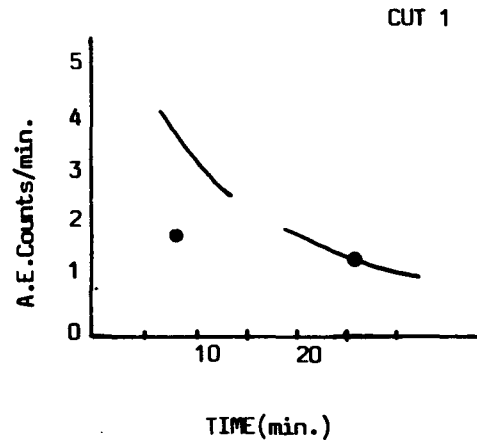
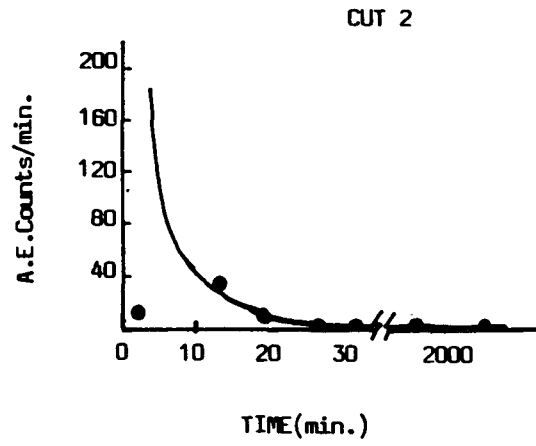
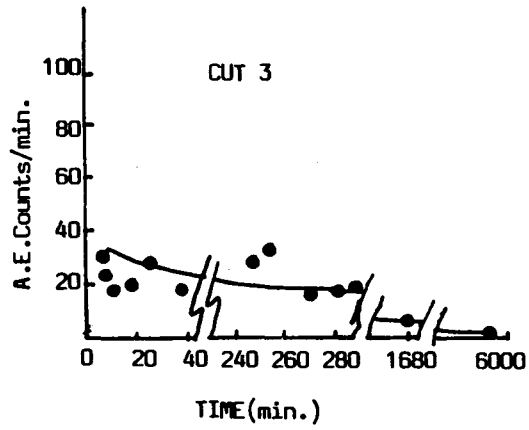
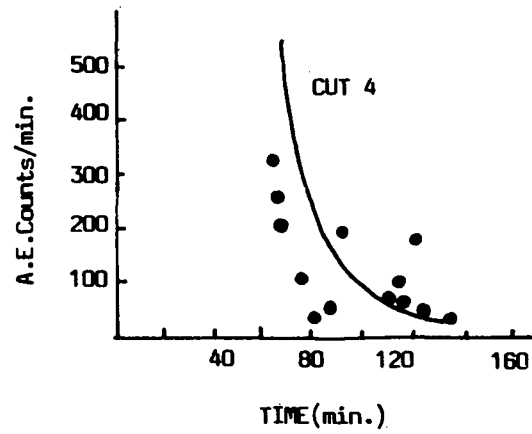
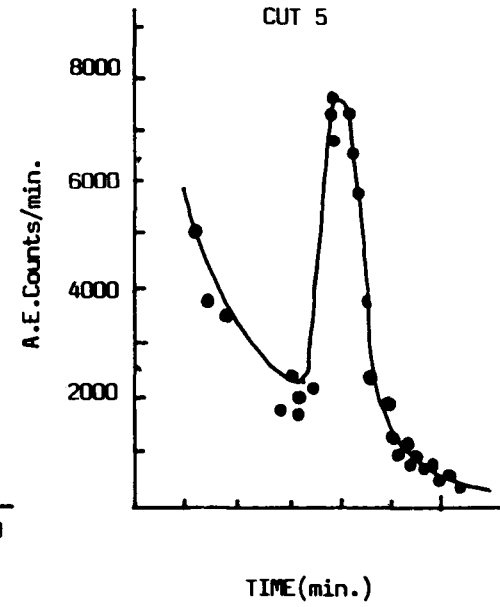
Fig 35: Decay of Ae Count with time as Related to Stability (Koener, McCabe & Lord, 1980)
