Case Studies in Geotechnical Engineering Constructions

B. R. Srinivasa Murthy

Keywords Case history · Investigation deficiency · Innovative solutions · Reinforced earth · Soil nailing · Under-slab drainage

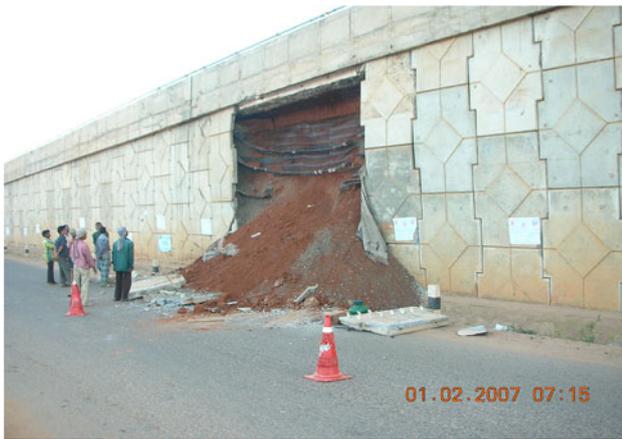
Fig. 6 Collapse of RE wall

A geo-grid reinforced earth retaining wall for a fly-over along the National Highway No. 4 was constructed a few years back. The wall height is varying from 2 to 12 m. At a location of about 7–8 m height of the wall there was snapping of connection between facing element and the geo-grid reinforcement and there was sudden failure of the RE wall. The failure had taken place over a length of about 10 meters (Figs. 6, 7, and 8).

The soil in the failed zone appeared to be in good condition as required from an RE wall point of view. In fact the failure plane had not gone beyond a meter from the wall face which was the boundary of the drainage zone of granular material. The soil behind the failed zone was standing near vertical indicating the sufficiency of the

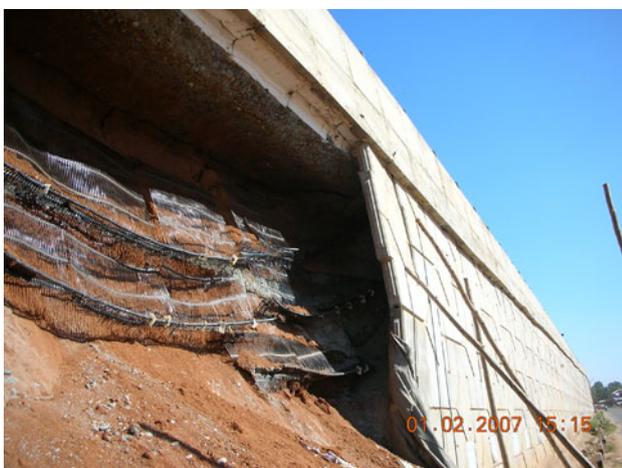
Fig. 8 Exposed friction slab

reinforcement layers and good quality of compaction. The failure was essentially in the form of collapse of the panels due to snapping of the connecting polyester cleats/clamps, perhaps initially of the upper layers. The number of geogrid reinforcement layers provided was found to be reasonable. There was variation in the grade of geo-grid increasing with depth.

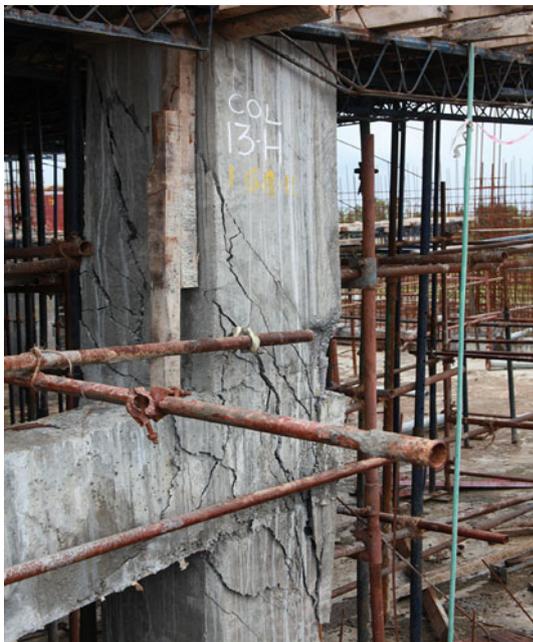
Fig. 54 Crushing of the column due to uplift

The adverse effect of uplift pressure not accounted in the design on the entire basement of a building in Chennai is shown here (Figs. 53, 54). The building had two basements and the ground water level rose up to the ground level causing extensive damage to the basement floors in non-tower area lifting the building by almost 1.3 m in the farthest point. The external drainage system with dewatering bore-wells at 10 m c/c all along the periphery brought the system to some equilibrium. Permanent passive anchors are being installed to prevent the future uplifts after partially dismantling the building.

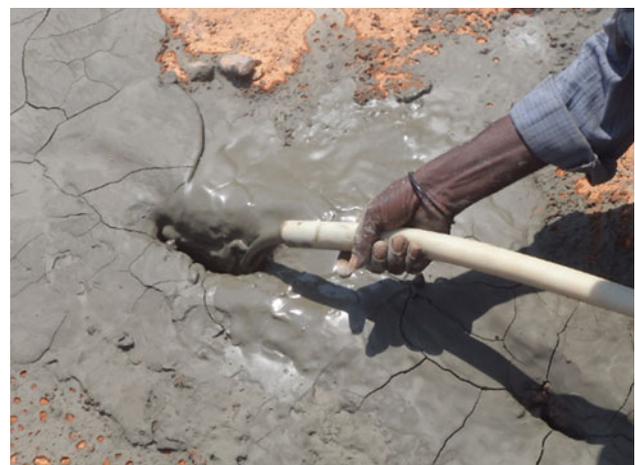
Fig. 63 Grouting of the cracks

A detailed investigation revealed that the earlier installed piles had not been provided with capping beams. The piles had become floating system. Also it was possible that while installing the grouted nails at –11 m level the angle of the grouted nail not being properly maintained might have hit the bottom tip of the RCC pile. It was indicative from the bulging at –13 m level that the unset grouted nails had not offered any resistance. The cracks had developed to quite large depths of more than a meter. Immediately cement slurry grout with non-shrink grout compound was pumped into the cracks. The amount of grout consumed was quite extensive and it was more than 100 bags of cement and it was not possible to ascertain where all it has gone (Fig. 63).

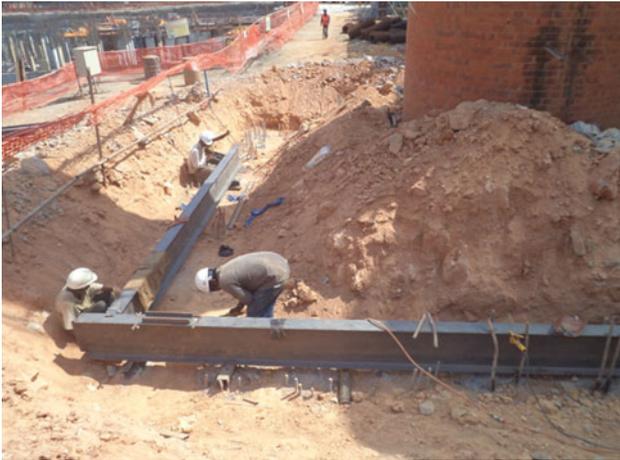
Fig. 64 Capping beam on the RCC piles

The RCC piles were interconnected at ground level with ISMB encased in concrete as capping beam (Figs. 64, 65). Further the structural shoring in the form of struts was provided from the all ready cast raft and foundations at a distance more than 12 m from the micro piles to the wailer beam at –11 m level (Figs. 66, 67, and 68). With this earth shoring, grouting at the top, structural shoring and strutting, it was observed from the total station survey that the movement of the top of the Chimney

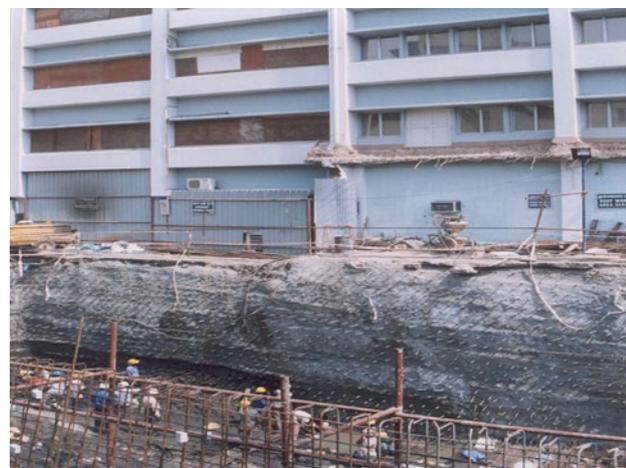
Fig. 77 Driven nails below the existing foundation at Chennai

existing building the nails were introduced in both upward and downward inclination from the clay layers to penetrate into the sandy layer to provide better frictional resistance (Figs. 76, 77).
