*Proceedings of Indian Geotechnical Conference 2020  
December 17-19, 2020, Andhra University, Visakhapatnam*

## Geotechnics of a Unique Irregular High-Rise Statue

**Abstract.** Construction of a 107 m (351 ft) high Shiva statue on a hillock at Nathdwara, Rajasthan posed several challenges both geotechnical and structural. Detailed geotechnical investigation showed the presence of quartzite rock from the ground surface that is highly fractured at shallow depths and improves in quality with increasing depth. Rock anchors were provided for stability against wind and earthquake loading. The slopes in the surrounding areas were stabilized effectively by suitable measures. The structure details and other aspects of the elegant monument are described.

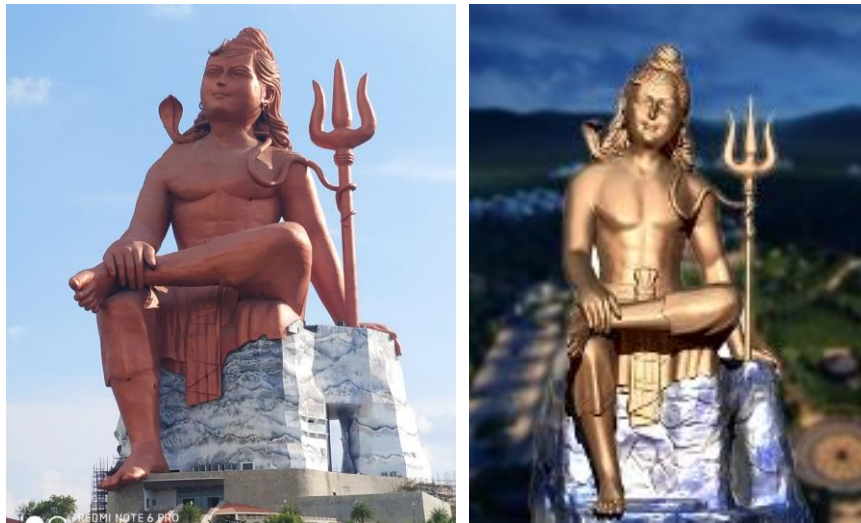
**Fig. 1.** Photograph (left) of the 107 m (351 ft) high statue shows Lord Shiva in sitting pose with trishul by the side. Photo on the right is the sculptor's imagination (model)

Fig. 1 presents a photograph of the statue [2] showing Lord Shiva in a pleasing appearance and the artist's impression.

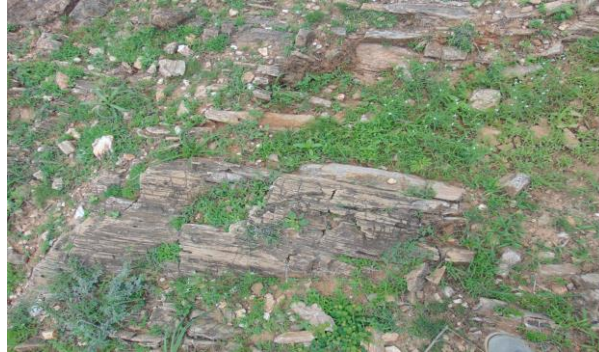
**Fig. 2.** Site overview

The general trend of hill is N-S with inclined to steep dips. The area is traversed by numerous small to big nallas (drains). Three small prominent main seasonal nallas start from higher elevated area and merge into a downstream water pond. The general ground slope of the area is towards north east. Fig 2 is a photograph showing the site overview.

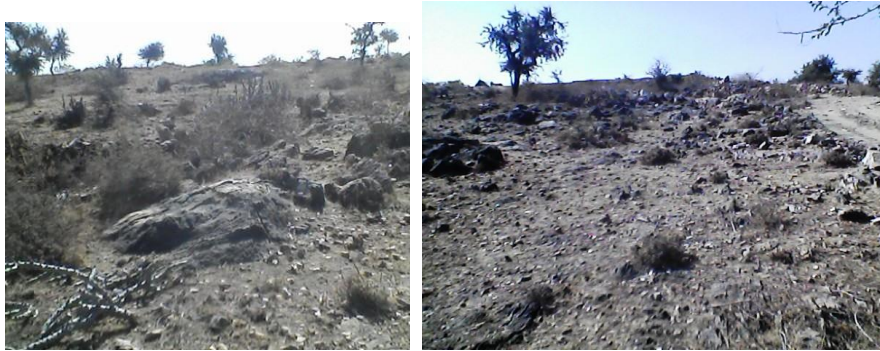
**Fig. 3.** View of site: See the rock exposed at ground level

Photographs of the site are illustrated on Fig. 3.

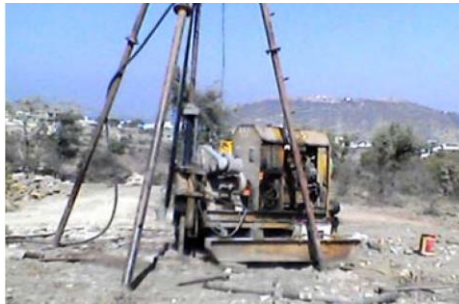
Drilling was done using NX size double tube core barrel with diamond bits. Water was circulated to lubricate and cool the bit as well as to flush out the cuttings. A photograph of the drilling in progress is illustrated on Fig. 5.

**Fig. 5.** Drilling in progress

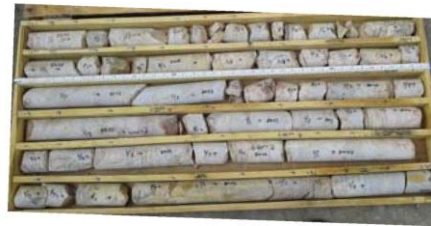
**Fig. 6.** Typical rock cores collected

Quartzite (rock) is encountered from ground surface to the maximum explored depth of 15 m. The rock is moderately weak to strong and moderately to slightly weathered. Typical rock cores collected are illustrated on Fig. 6.

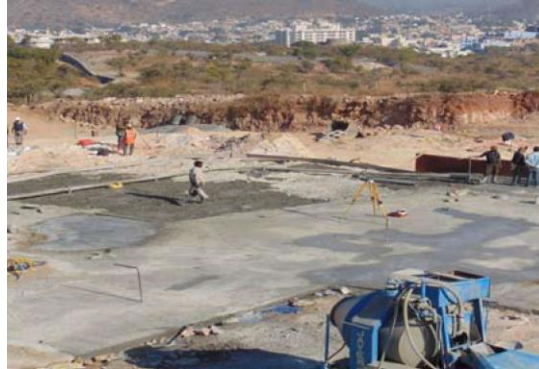
RCC raft foundation with raised pedestals to support the statue was cast at 4m depth. Bearing capacity analysis was done as per IS: 12070-1987 RA 2010 [5]. Based on assessment of RMR of the rock mass and the crushing strength of the rock, the raft was designed for a net allowable bearing pressure of 700 KN/m<sup>2</sup>.

**Fig. 8.** Foundation level preparation

A photograph showing the foundation level prepared for raft construction is illustrated on Fig. 8. Fig. 9 shows the pedestals constructed over the raft.

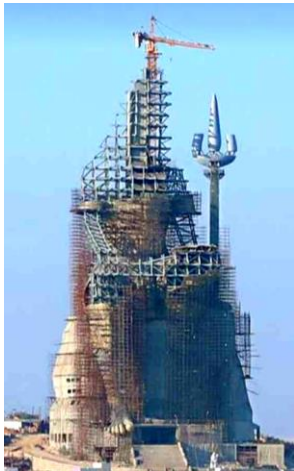
External skin of the statue was made through in-situ concrete pouring in specially made glass-fibre moulds. To properly support this skin and to transfer the wind forces / self-weight, special non-corrosive connections were designed. The thickness of skin shell varied from 200mm to 400mm. External geometry of statue at every 3m interval has been used to prepare structural framing by superimposing all floor plans and arranging RCC walls designed as per IS: 456-2000 [8] & steel columns which can be taken through to maximum possible heights.

**Fig. 11.** Construction in progress

Fig. 11 presents the statue under construction. Fig. 12 presents the fully constructed statue and the development around it depicting Lord Shiva majestically overseeing and benevolently ruling over the surroundings.

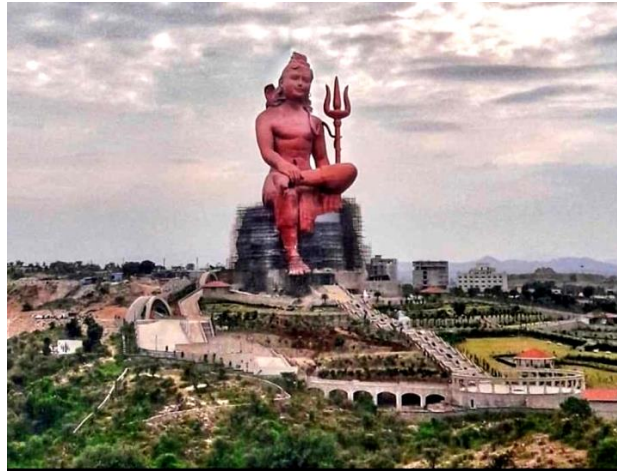
**Fig. 12.** View of the statue & surroundings
