*Proceedings of Indian Geotechnical Conference 2020  
December 17-19, 2020, Andhra University, Visakhapatnam*

## **Instrumented Pile Load Tests in Southern India**

This paper presents a case study for the instrumented tests performed in Kochi for a Test pile at Kochi Metro Rail Project. Geo Dynamics in association with Kochi Metro Rail Corporation (KMRL) performed state of the art instrumentation studies during vertical as well as lateral load tests. Embedment type Strain gages were installed in the pile during pile casting to perform instrumentation study. An inclinometer casing was also installed in order to monitor the deflection of pile along the length during lateral load test. The pile was a test pile (mono pile) with diameter of 2m and length of 50m. A Crosshole sonic logging test was also performed before the load tests and it was concluded that the pile has major defect from 44m to pile toe.

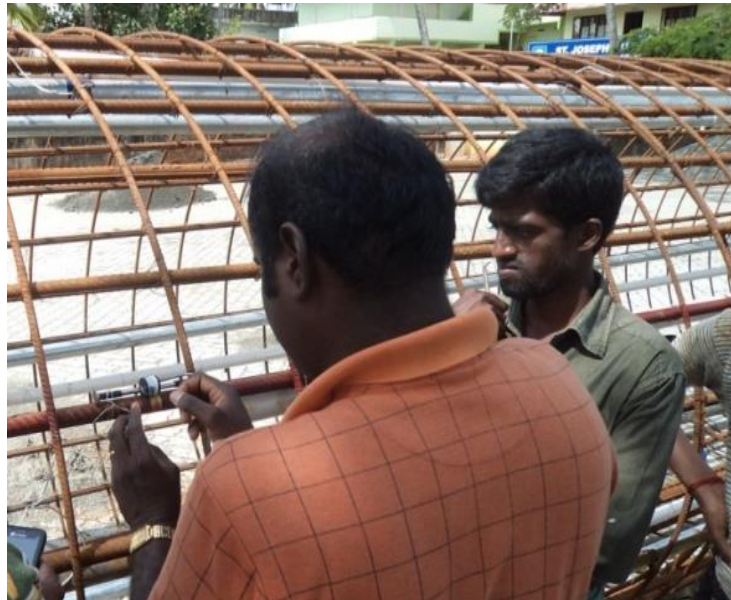
A cyclic load test was planned and the design load on the pile was 850 tons while the test load was 1275 tons. Combination of anchor piles and kentledge was used to provide reaction during testing. The instrumentation consisted of 56 embedment type vibrating wire strain gages. It was planned to install gages at every stratigraphy change (however not greater than 3m). The strain gages were installed in sets of 2 and 4 alternatively. Whenever 2 gages were installed they were at  $180^{\circ}$  and whenever four strain gages were installed they were located at  $90^{\circ}$ . Photograph of the strain gage installation is presented below as Figure 1.

**Fig. 1.** Strain gage installation in progress

As stated above, 56 vibrating wire strain gages were installed in the pile. At the time of testing 9 gages were not functional. It is possible that while cage lowering operations or during concreting these gages and/or cables might have damaged. However, other gages provided reasonable data for the analyses and interpretation. Strain gages located below 44m indicated unusual readings due to presence of defect. Other strain gages provided consistent readings implying that the pile shaft is under compression. Photo shows the data collection in progress.

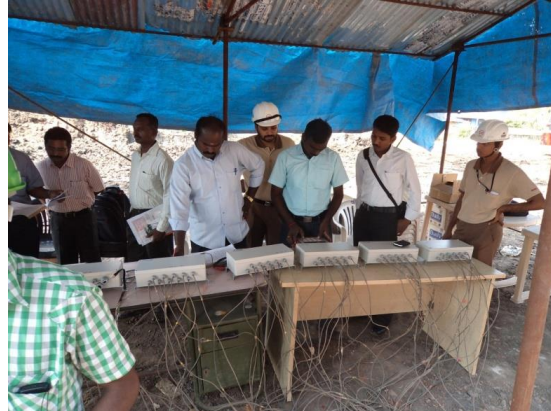
**Fig. 3.** Instrumented vertical load test – data collection in progress

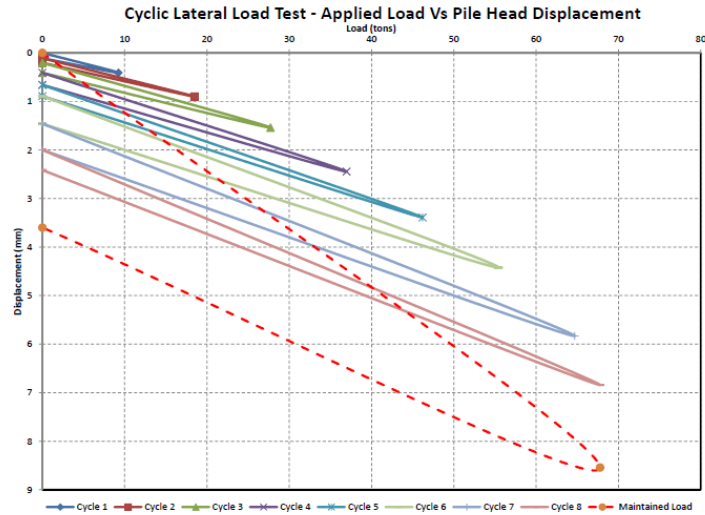
The pile was loaded to an initial load of 9.24 tons (1st cycle) and was unloaded to zero load. The next load cycles were 18.48 tons, 27.72 tons, 36.96 tons, 46.2 tons, 55.44 tons, 64.68 tons, and 67.76 tons. After each load increment corresponding displacements were measured and pile was unloaded to zero load. The pile was then again loaded to 67.76 tons and the same load was maintained for 24hrs after which the testing was terminated. Before maintaining the load, all the dial gages were reset to zero. The failure criterion was considered to be displacement of 12mm. Load displacement plot of the pile is presented below as Figure 6.

**Fig. 6.** Load-displacement plot – lateral load test

The maximum settlement was observed by dial gages to be 8.54mm when the load was maintained for 24hrs. Once the pile was unloaded to zero load then the net displacement of the pile was observed to be 3.6mm. The elastic recovery was around 4.94mm.

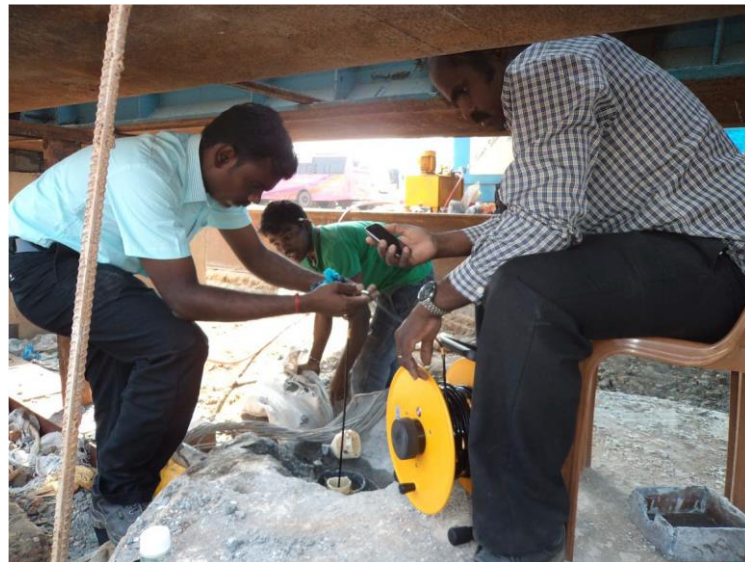
Inclinometer readings were taken after each loading cycle as shown in the Figure 7. A typical load deflection along the depth is also presented as Figure 8. Generally good agreement was observed between dial gage readings and deflection at the top observed by inclinometer. Based on the data collected by inclinometer, it can be inferred that the pile undergone some deflection even at 12m and below indicating that the actual point of fixity is somewhat lower than the theoretical calculations.

**Fig. 7.** Inclinometer reading being taken during lateral load test

Upon completion vertical load test, an instrumented cyclic lateral load test was performed on the same pile. The design lateral load on the pile was 45 tons while the test load was 67.5 tons. Pile deflection along the length of the pile was measured by means of inclinometer. Inclinometer casing was installed during pile concreting. The depth of the inclinometer casing was 15m which was determined based on theoretical point of fixity (12m).
