Indian Geotechnical Conference

IGC 2022

Mitigation of Micro and Macro Landslides – A Case Study

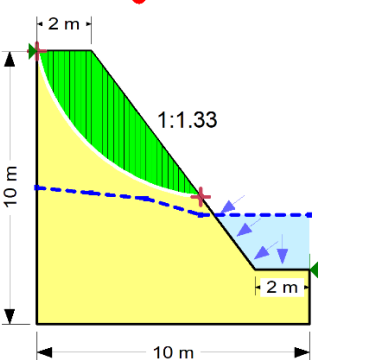
<p>Location 3: Hammiyalla (FOS_{critical}= 1.243)</p> <p>7(a)</p>	<p>FOS= <u>1.174</u></p>

However, from figure 7(a) and 8(a) face failures were observed at the locations which were not critical, Further more toe failures are likely to happen in the future which may further causes serious damage to the life and property.

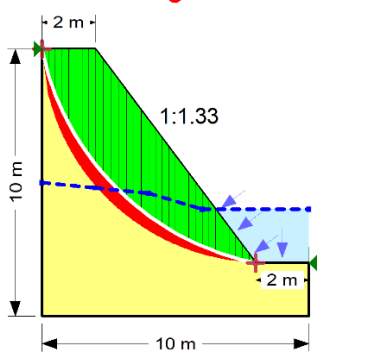
<p>7(b)</p>	<p>FOS= <u>1.243</u></p>

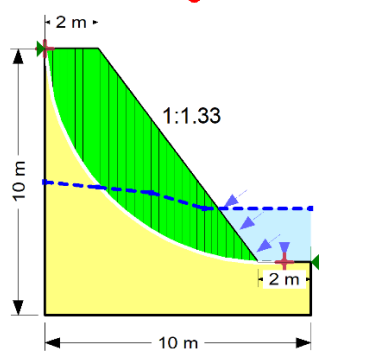
<p>7(c)</p>

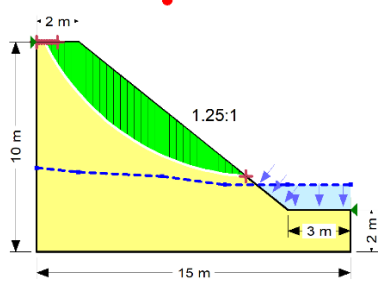
<p>Location 4: Between Ham-miyalla and Mukkodlu (FOS critical= 1.424)</p> <p>8(a)</p>	<p>FOS = 1.424</p>

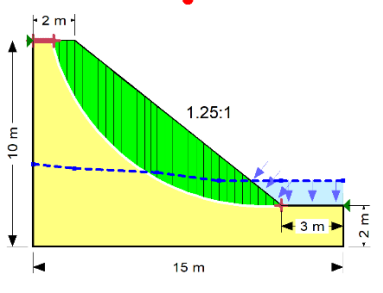
<p>8(b)</p>	<p>FOS = 1.477</p>

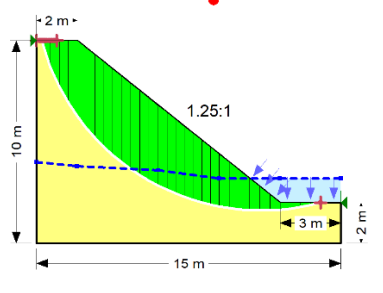
<p>8(c)</p>
<p>5</p> <p>FOS = 1.421</p>

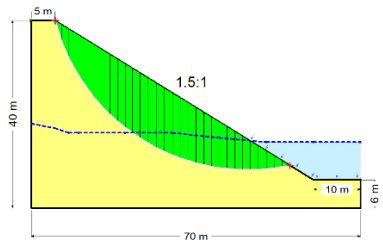
<p>Location 5: Mukkodlu (FOS critical= 1.364)</p> <p>9(a)</p>	<p>FOS = 1.364</p>

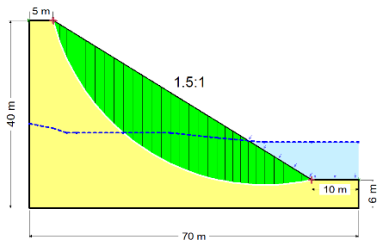
<p>9(b)</p>	<p>FOS = 1.392</p>

Toe failures as shown in figure 5(b), 6(b), 9(b) and 10(b) which exactly depict the actual failure which had happened at the site locations which were critical.

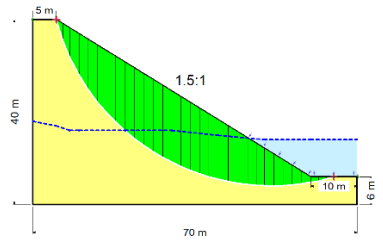
<p>9(c)</p>
<p>6</p> <p>FOS = 0.752</p>

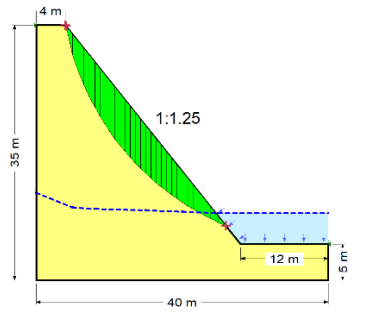
<p>Location 6: Madkeri (FOS critical= 0.725)</p> <p>10(a)</p>	<p>FOS = 0.725</p>
