*Proceedings of Indian Geotechnical Conference 2020
December 17-19, 2020, Andhra University, Visakhapatnam*

Forensic Study of An Earth Retaining System Failure

Anil Joseph¹, S Chandrakaran² and Babu T Jose³

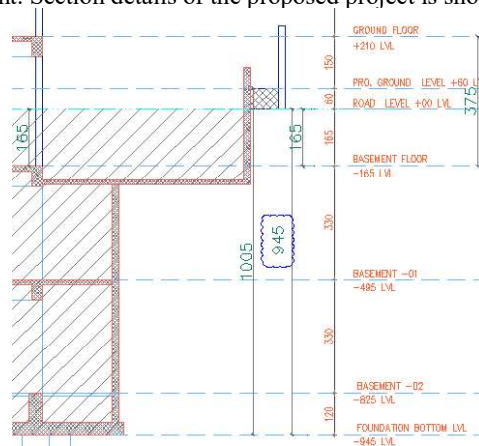
Fig. 3. Section Details of proposed commercial building

Excavation was done in 3 phases after completing the shoring works: During phase 1, excavation was carried up to 2m and strutting work supported on soldier pile was provided, in the phase 2, excavation was carried up to 6.50m and in the phase 3, excavation was planned up to 10m as directed by the structural consultant. Considering the general impervious nature of clay in Cochin, Dewatering system was not suggested by the consultant. Section details of the proposed project is shown in figure 3.

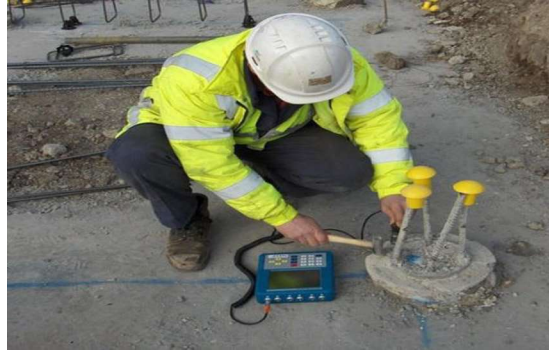
Pile integrity testing (PIT) was done on 8 R.C. bored piles which were installed in the site. The aim of testing was to assess the pile integrity for potential problems like cross-sectional changes, honeycombing, concrete quality, continuity etc. The tests were conducted in accordance with ASTM D5882 [9]. As per the test results, the collapsed piles failed at depths around 14.5m to 15.5m from the ground level. And length of the standing piles was found to be approximately 30m as specified in the drawings. The photos of integrity test in progress and the results are shown in figure 8(a), figure 8(b) and figure 8(c)

Fig. 8(a). Conducting pile integrity test on piles

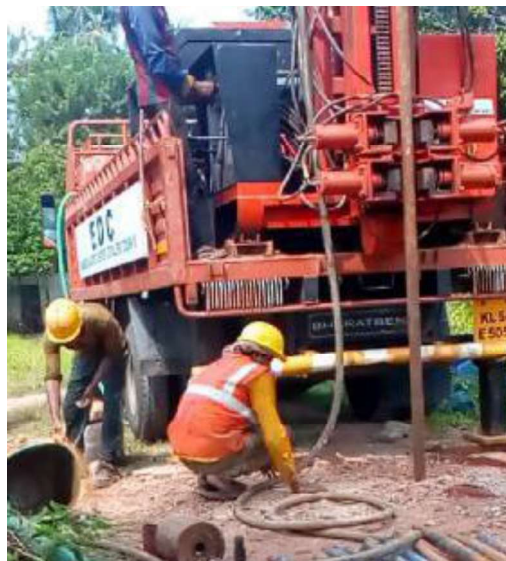
Additional investigation soil profile was found in conformity with the initial soil investigation carried out. From the study of the borehole it was noted that the top 5.70m comprise of fill. Below this soft clay was noted extending up to a depth of 11.40m. This was followed by medium dense to very dense sand extending up to a depth of 19.10m. Below this stiff to very stiff clay was noted extending up to a depth of 27.80m. This was followed by very dense sand extending up to a depth of 32.50m. From 32.50m to 40.00m decayed wood was noted. Below this very dense sand was noted up to a depth of termination of borehole at 48.00m. Water table was noted at 4.80m below ground level in the borehole during the time of investigation. Soil test in progress at site is shown in figure 9.

Fig. 9. Confirmatory soil investigation in progress.

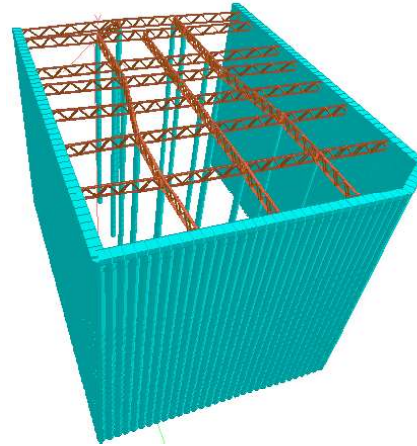
1110 kNm (179 mm deflection) and 2090 kNm (400 mm deflection) respectively. Strutting system provided comprises of two ISMC200 section connected by 65 mm x 65 mm x 6 mm L laced sections on both sides. Figure 10 shows the details of braced steel strutting system. The touch pile system comprising of 900 mm diameter piles without strutting was adequate for excavation upto 6m depth. The strutting system was found to have marginal deficiency, when the depth reached 7.5m, to take up the earth pressure and it was observed that for the depth of 10m, the provided touch piling system and strutting was grossly inadequate to take up the lateral thrust.

Fig. 11 (b). 3D model of provided touch pile system for 9.5m retention

1. For the proposed depth of excavation of 10m, the shoring pile with single strut propping system used in this project is found inadequate to take the lateral forces.

2. The reinforcement of the shoring piles is found inadequate against bending with single strut propping system at top provided for the proposed depth of excavation of 10m.
3. The strutting system currently used is a series of trussed beams in grid pattern, but not orthogonal to each other. This will have a tendency to make the grid system skewed and to facilitate further yielding of the props.
4. The soil at current depth of excavation has turned very soft on account of water seepage. This has caused considerable weakness of the interface soil. High thrust from the shoring pile at the interface has caused yielding of this soil. Subsequent increase in unsupported length of pile is also a reason for the failure of the pile in bending.

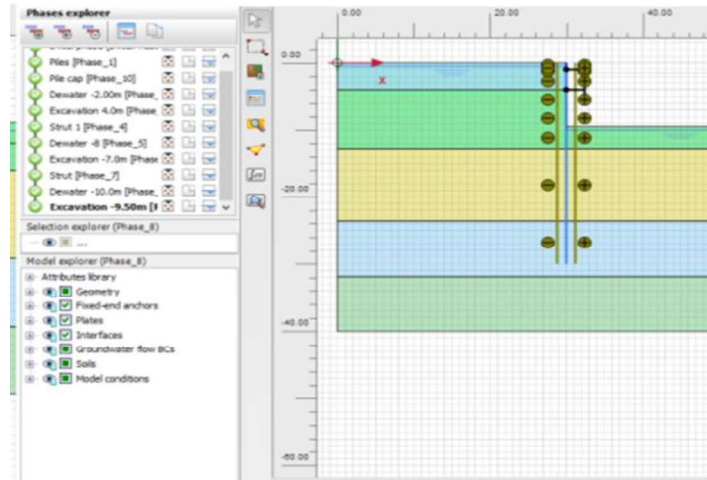
Fig. 13 (a). Model of excavation phases using PLAXIS software
